# **Westmead to The Bays and Sydney CBD**

**Technical Paper 3  
Non-Aboriginal heritage**

# Sydney Metro West

Non-Aboriginal Heritage

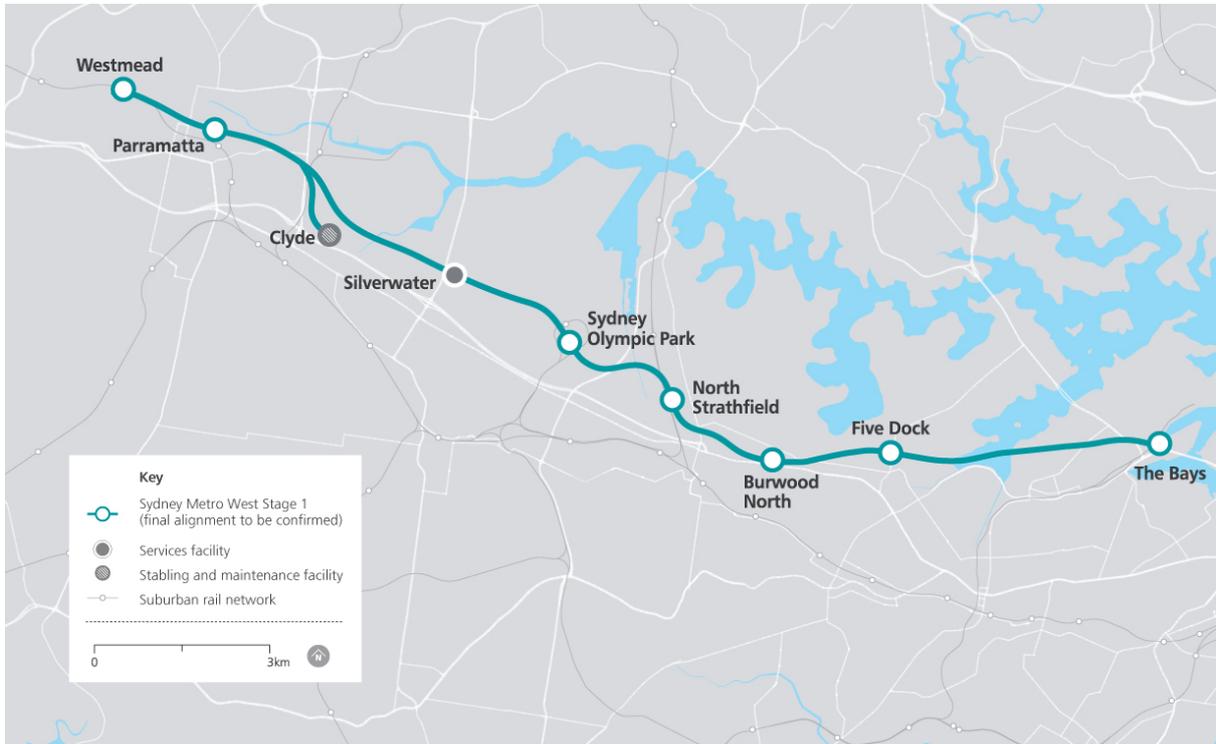
**Figure 1: Sydney Metro West – Stage 1 overview**

Sydney Metro West would mainly be located underground in twin tunnels. Stage 1, which is subject of this assessment, extends from Westmead to The Bays (refer to Figure 1).

The indicative alignment for Stage 1 is shown in Figure 1. The Stage 1 alignment extends between Westmead in the west to The Bays in the east. The study area for Stage 1 is shown in the maps presented in Figure 2 to Figure 10.

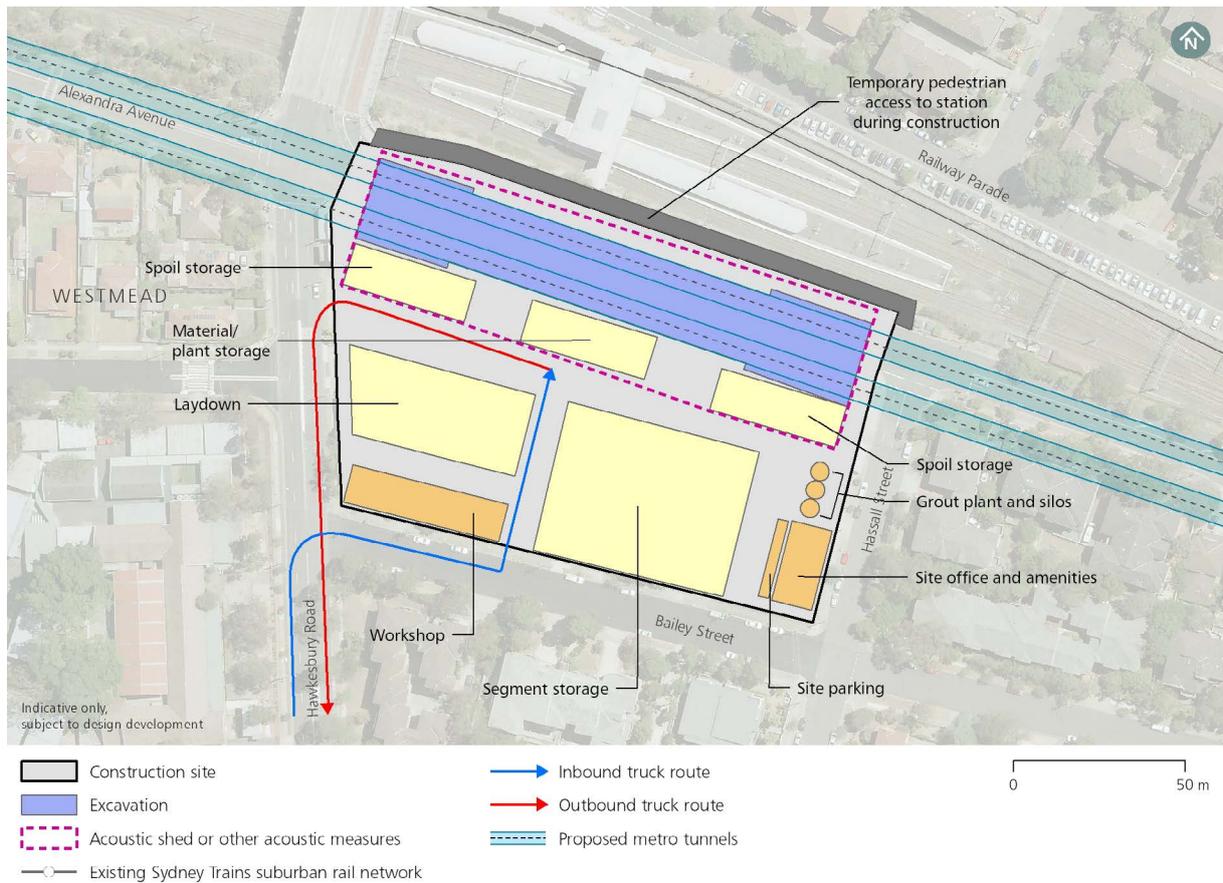
**Figure 11: Westmead metro station construction site layout (indicative)**

The Westmead metro station construction site is illustrated in Figure 11. All existing structures would be removed from the site in order to clear the area for future excavation and construction. The excavation depth of the station would be around 32 metres in depth. An acoustic shed would be constructed at the construction site.

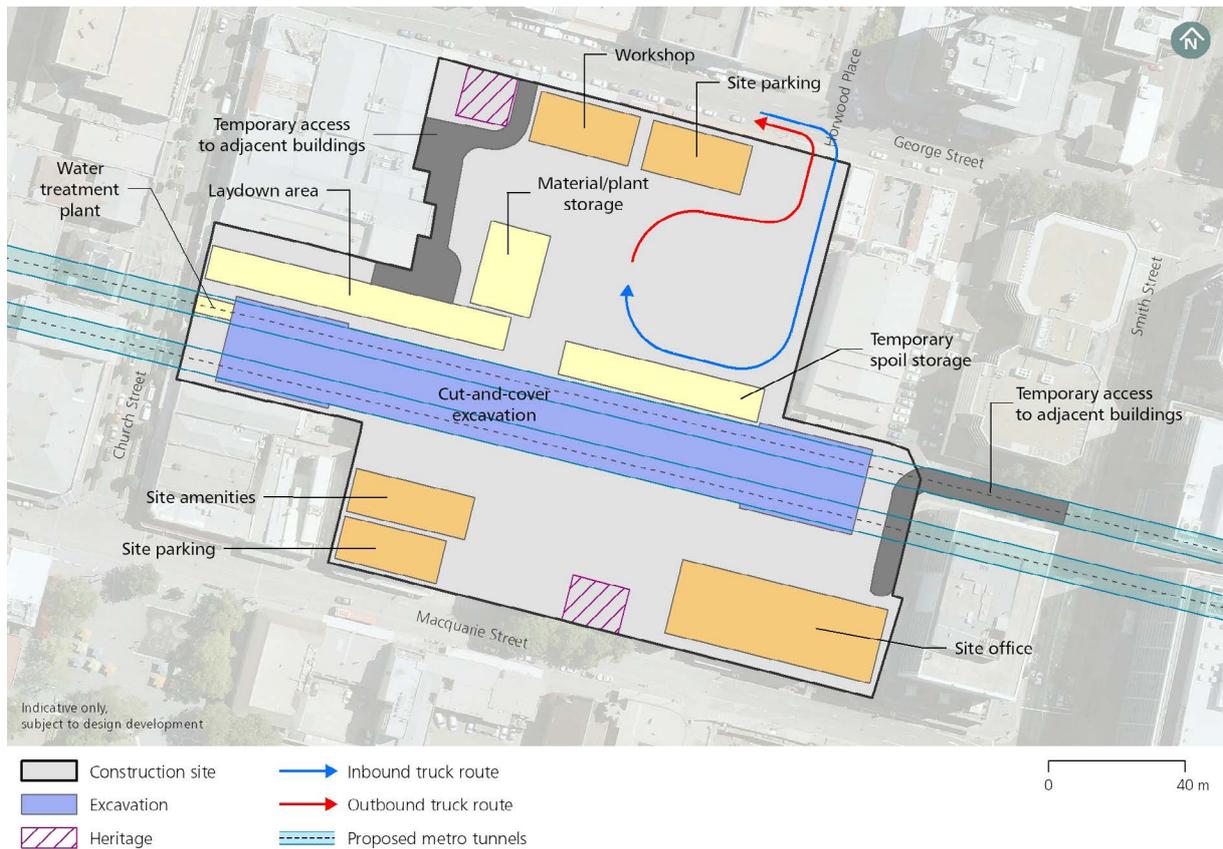
**Figure 12: Parramatta metro station construction site layout**

The final excavation depth of this station would be around 25 metres in depth.

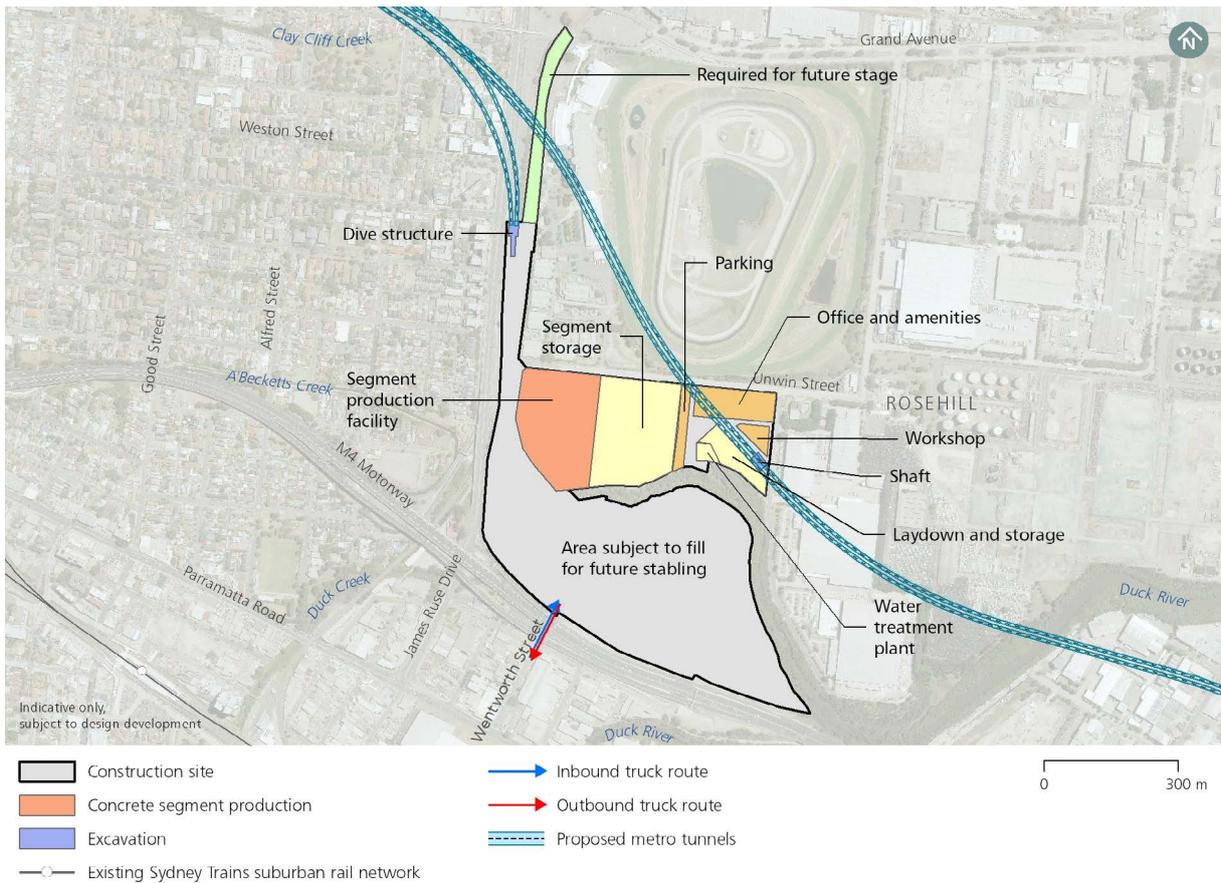
**Figure 13: Clyde stabling and maintenance facility construction site layout**

The Clyde stabling and maintenance facility would be constructed at ground level, at a site bounded by James Ruse Drive, Unwin Street, Shirley Street and the M4 Motorway in Clyde. This area is currently occupied by a variety of industrial facilities and the Sydney Speedway facility. Works would involve the removal of all structures across the site to allow the construction of the proposed stabling and maintenance facility, with the exception of the façade of the RTA Depot 1B and 5 Unwin Street, Rosehill. The construction site would also include the excavation and construction of the dive structure and tunnel portal and a services facility shaft at Rosehill. The construction site and areas of excavation are illustrated in Figure 13.

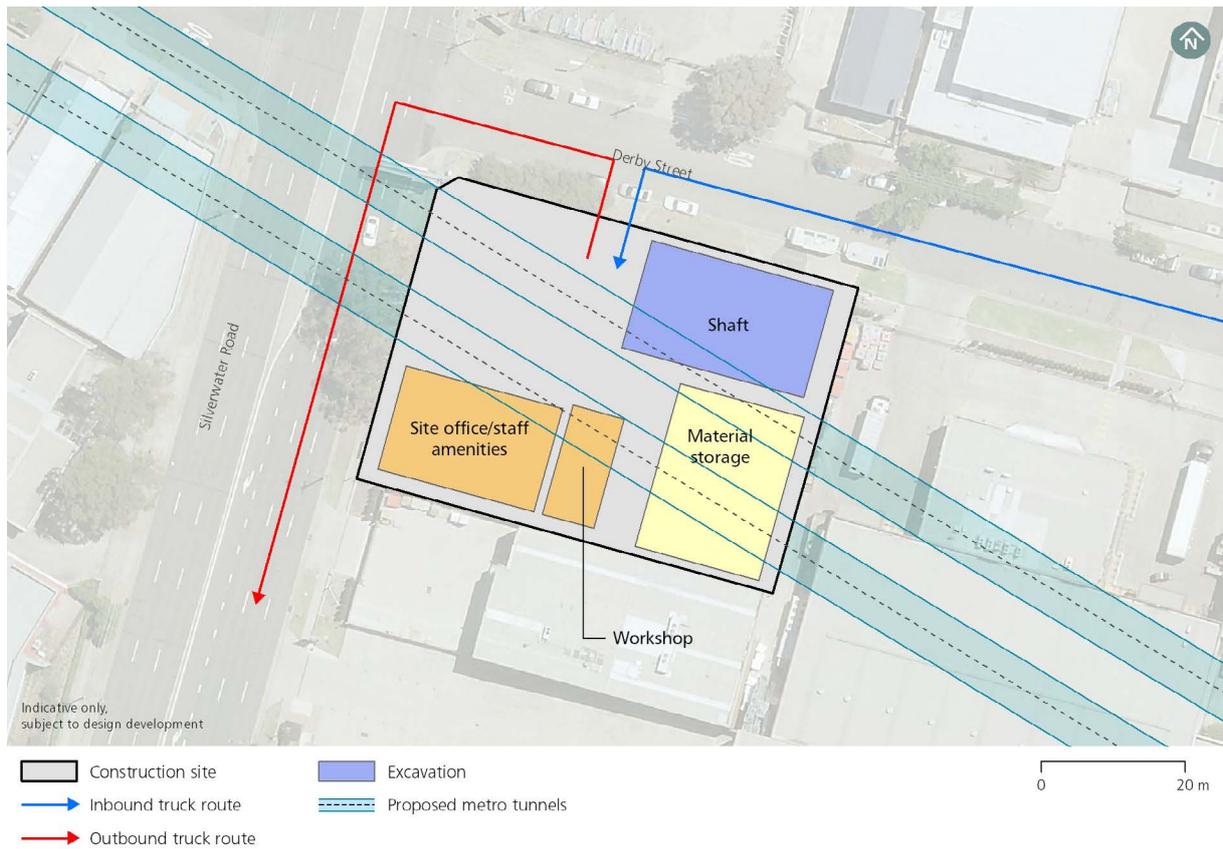
**Figure 14: Silverwater services facility construction site layout**

The Silverwater services facility would be constructed as a vertical shaft excavation, located on the corner of Silverwater Road and Derby Street in Silverwater. The site is currently a vacant lot. The construction site and area of excavation is illustrated in Figure 14.

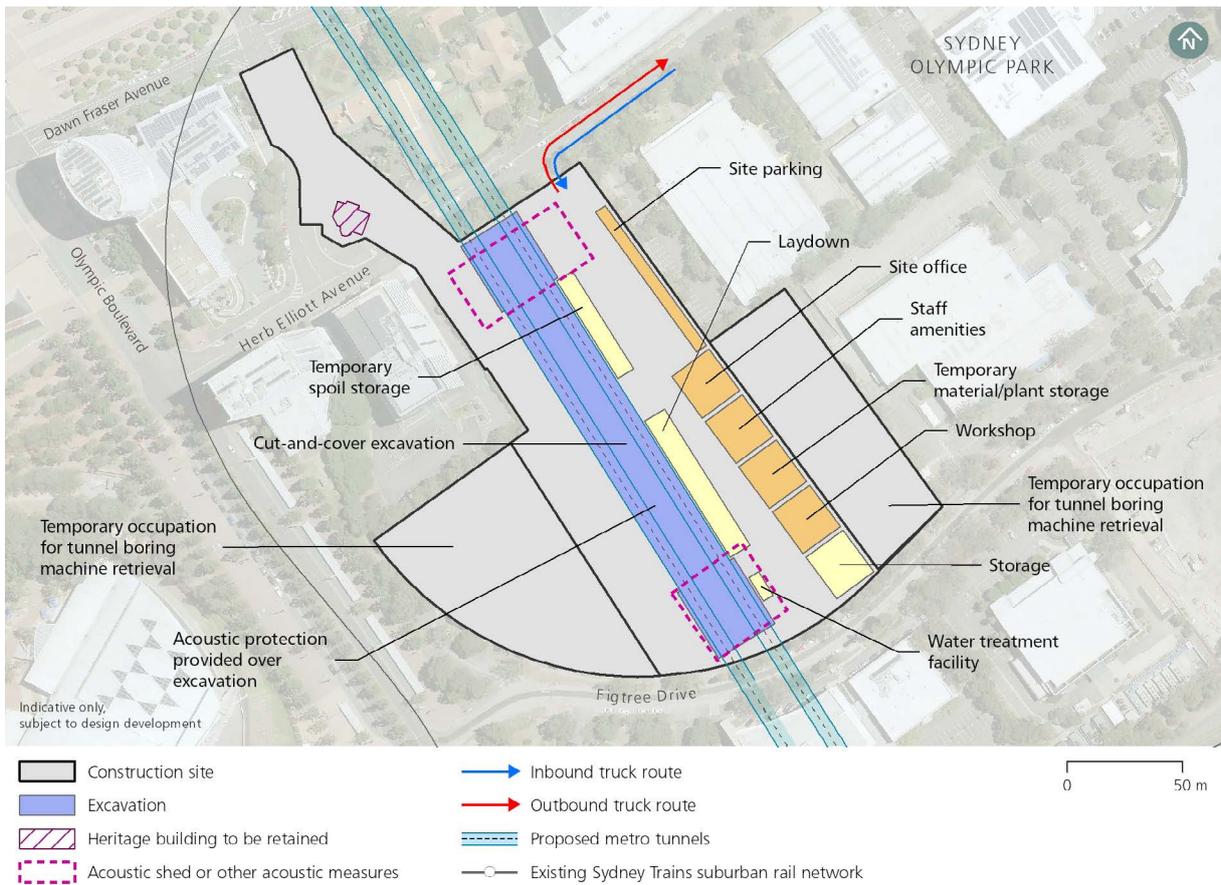
**Figure 15: Sydney Olympic Park metro station construction site layout**

Sydney Metro is currently investigating alternate construction options to cut and cover in the vicinity of Herb Elliot Avenue.

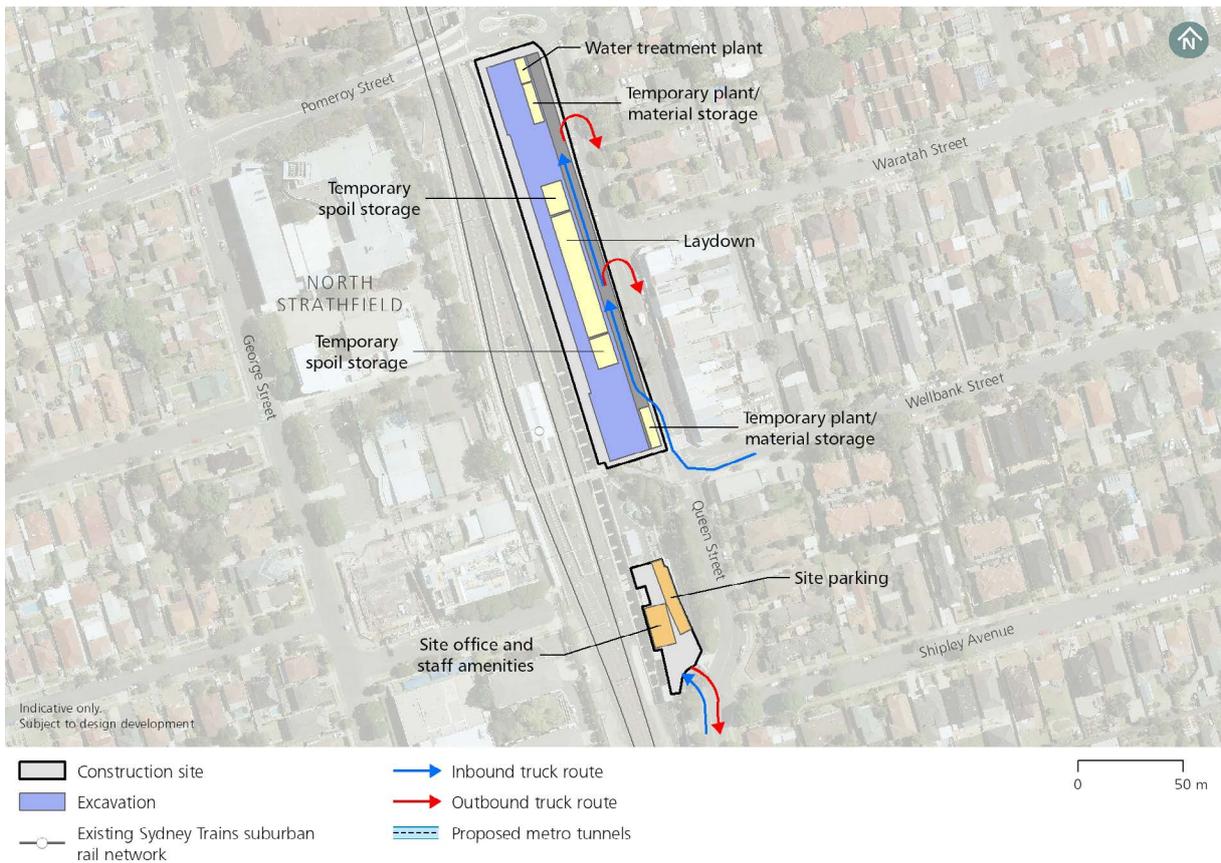
**Figure 16: North Strathfield metro station construction site layout**

The North Strathfield metro station construction site is illustrated in Figure 16. The final excavation depth of this station would be around 18 metres in depth.

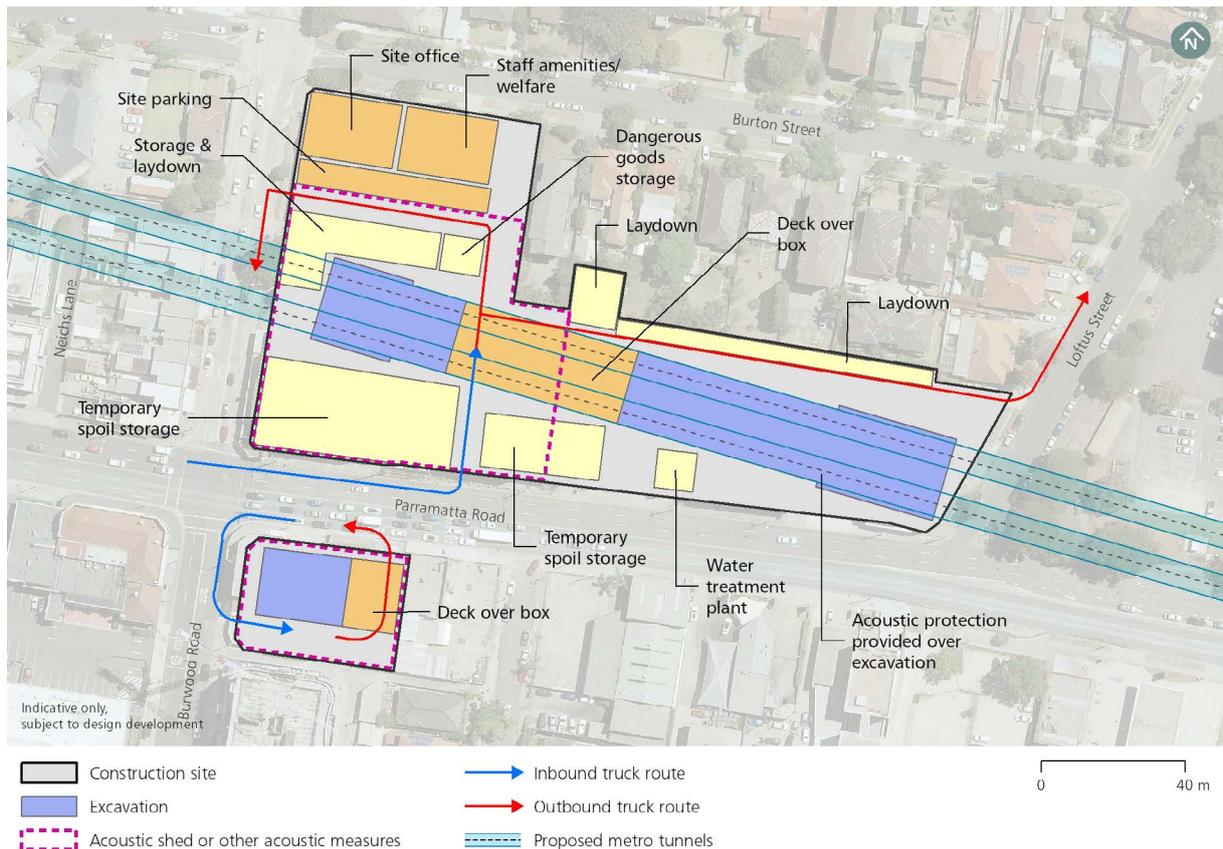
**Figure 17: Burwood North Station construction site layout**

The Burwood North Station construction site is illustrated in Figure 17. All existing structures would be removed from the site in order to clear the area for future excavation work and construction. The final excavation depth of this station would be around 32 metres in depth. Acoustic sheds would be constructed at the Burwood North Station construction sites.

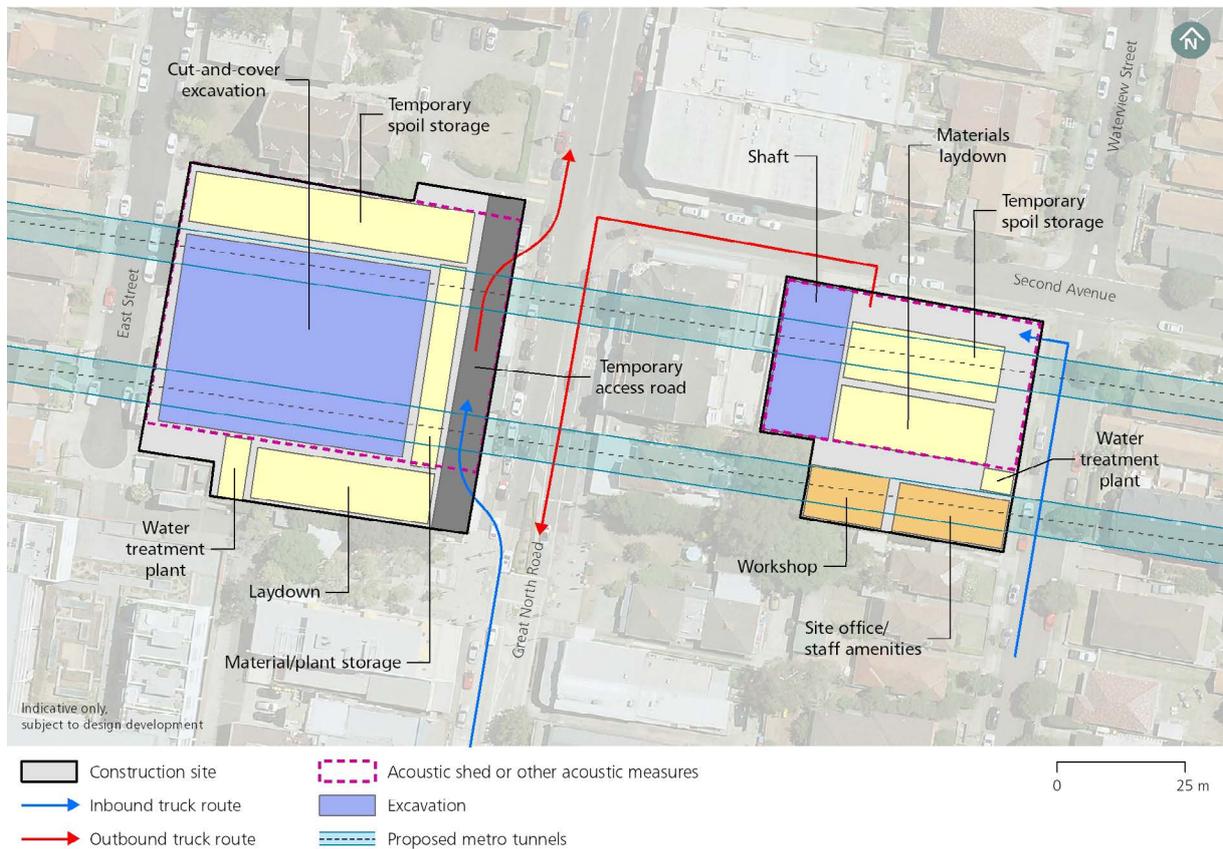
**Figure 18: Five Dock Station construction site layout**

The Five Dock Station construction site is illustrated in Figure 18. All existing structures would be removed from the site in order to clear the area for future excavation work and construction. The final excavation depth of this station would be around 30 metres in depth. Acoustic sheds would be constructed at each construction site.

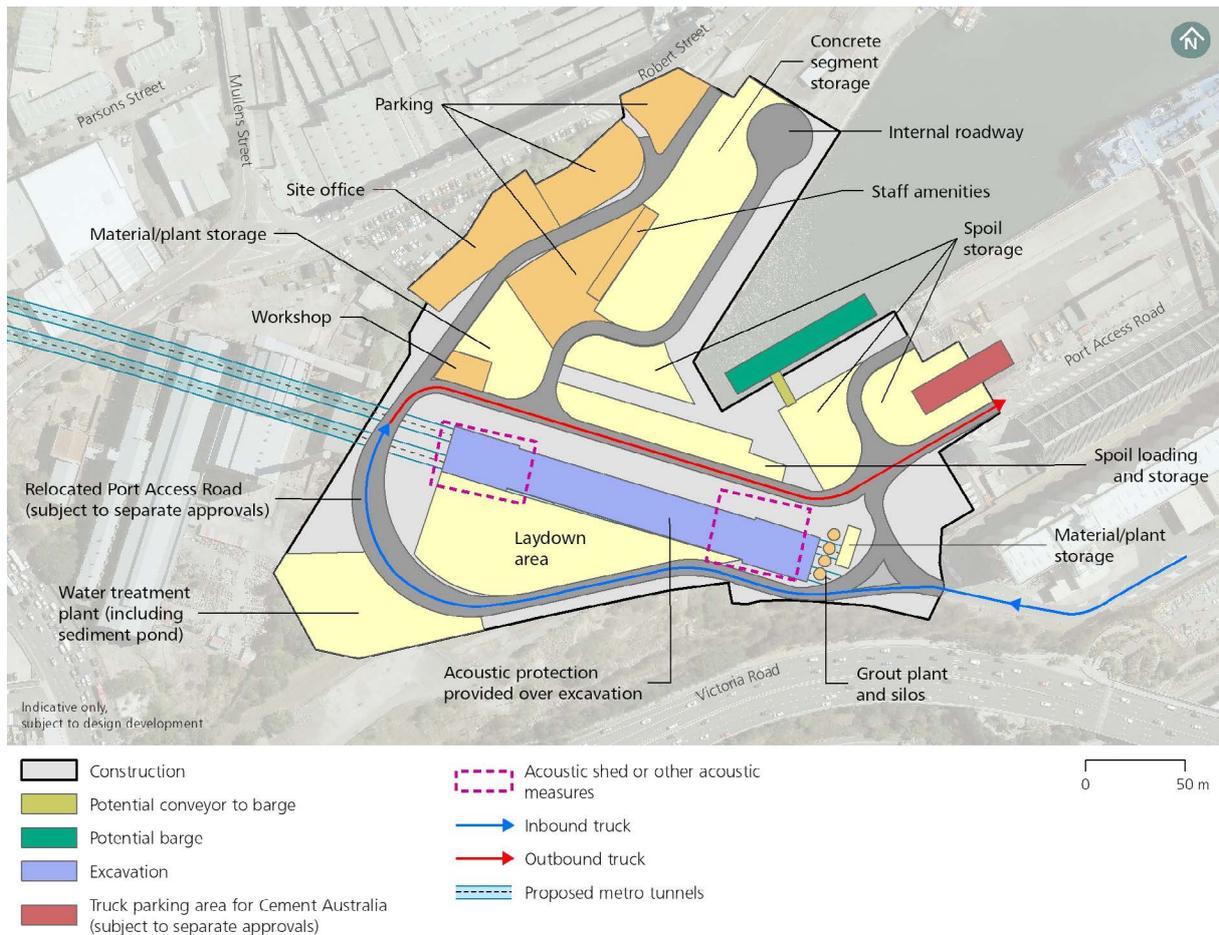
Figure 19: The Bays Station construction site layout

The Bays Station construction site is illustrated in Figure 19. All existing structures would be removed from the site in order to clear the area for future excavation work and construction. The final excavation depth of this station would be around 32 metres in depth.

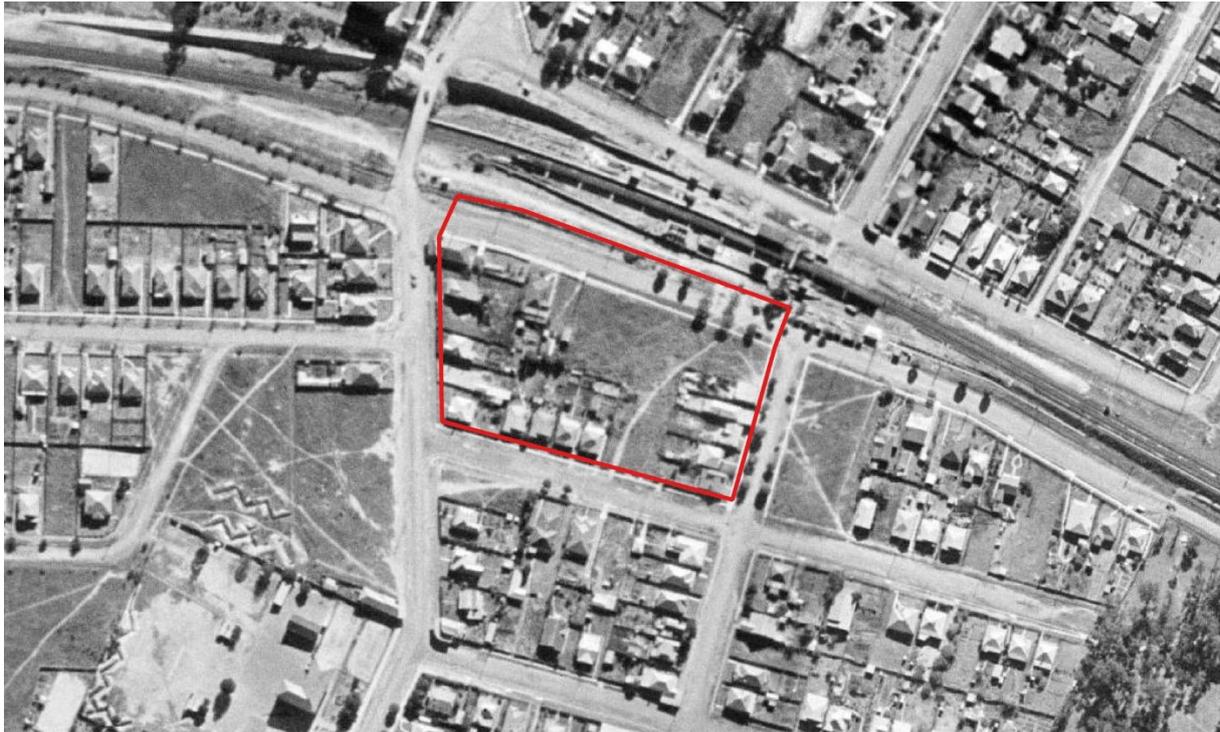
**Figure 25: 1943 aerial imagery showing the construction site outlined in red<sup>17</sup>**

1943 aerial imagery shows residential housing present within the construction site at this point. A number of these structures are extant today. In addition, a portion of the study area remained undeveloped, including Lot 1 DP4036 and Lot 1 DP1409 which remain undeveloped today.

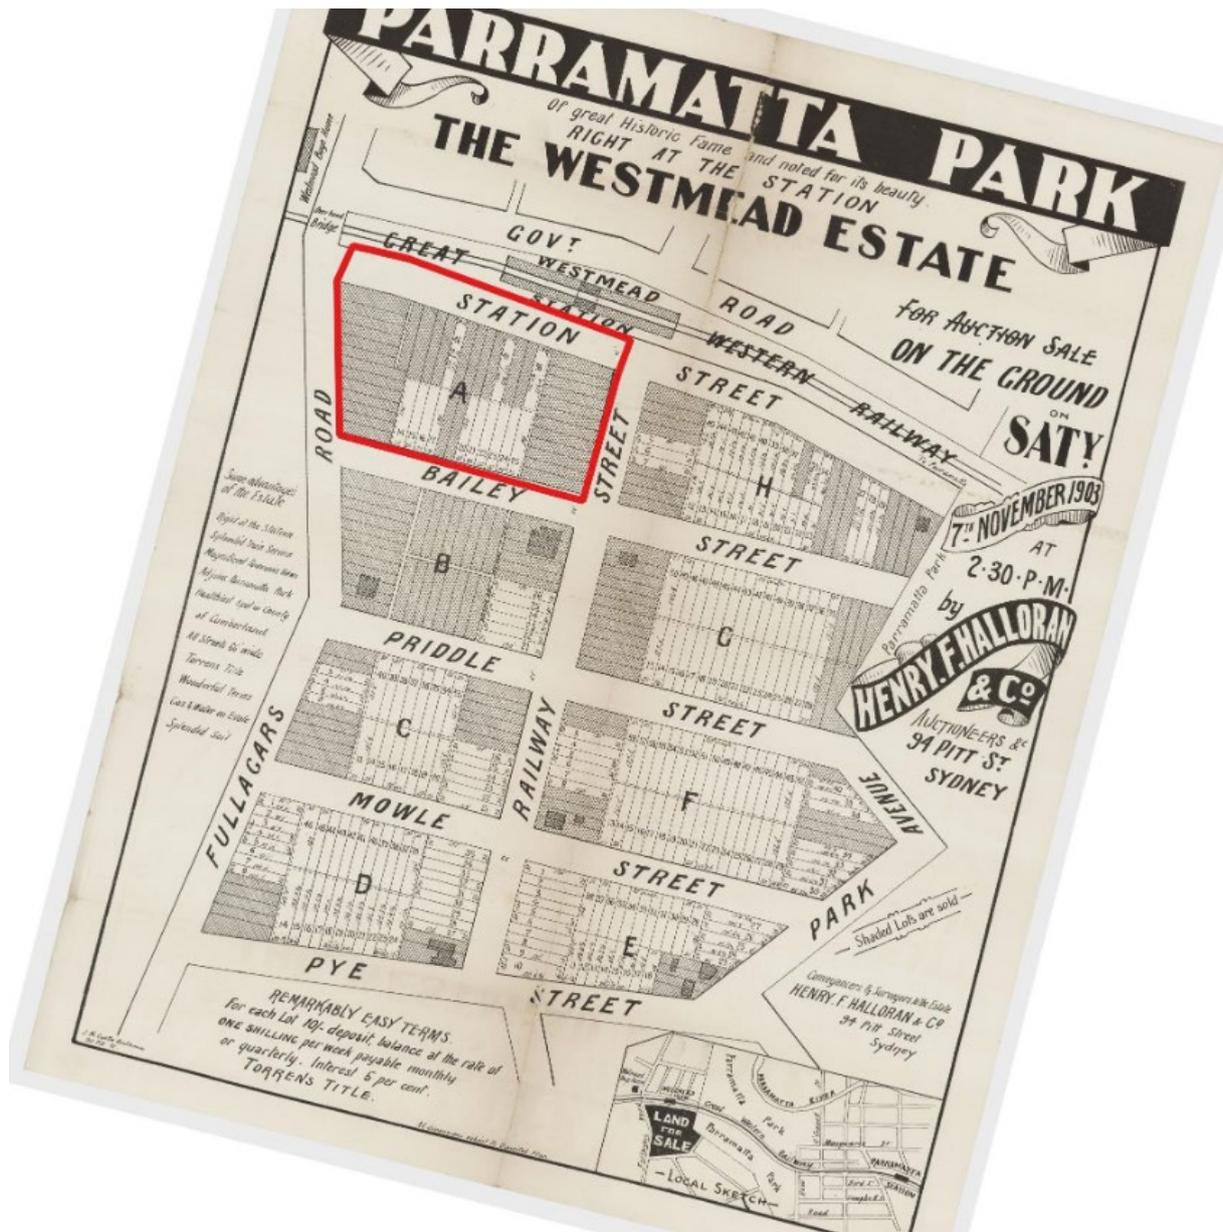
Figure 26: Detail of 1903 Westmead plan showing the construction site outlined in red<sup>18</sup>

The Westmead metro station construction site is located within the original curtilage of the Government Farm and Government Domain, developed from 1788 (Figure 21). However, there is no clear evidence of cultivation at the study area during this period. The site was advertised for subdivision from 1903 (Figure 26).

The study area extends into the Main Western Line rail corridor which had been established in 1861, and the Alexandra Avenue roadway which is known to have been vacant land up until the residential subdivisions seen within Figure 26.

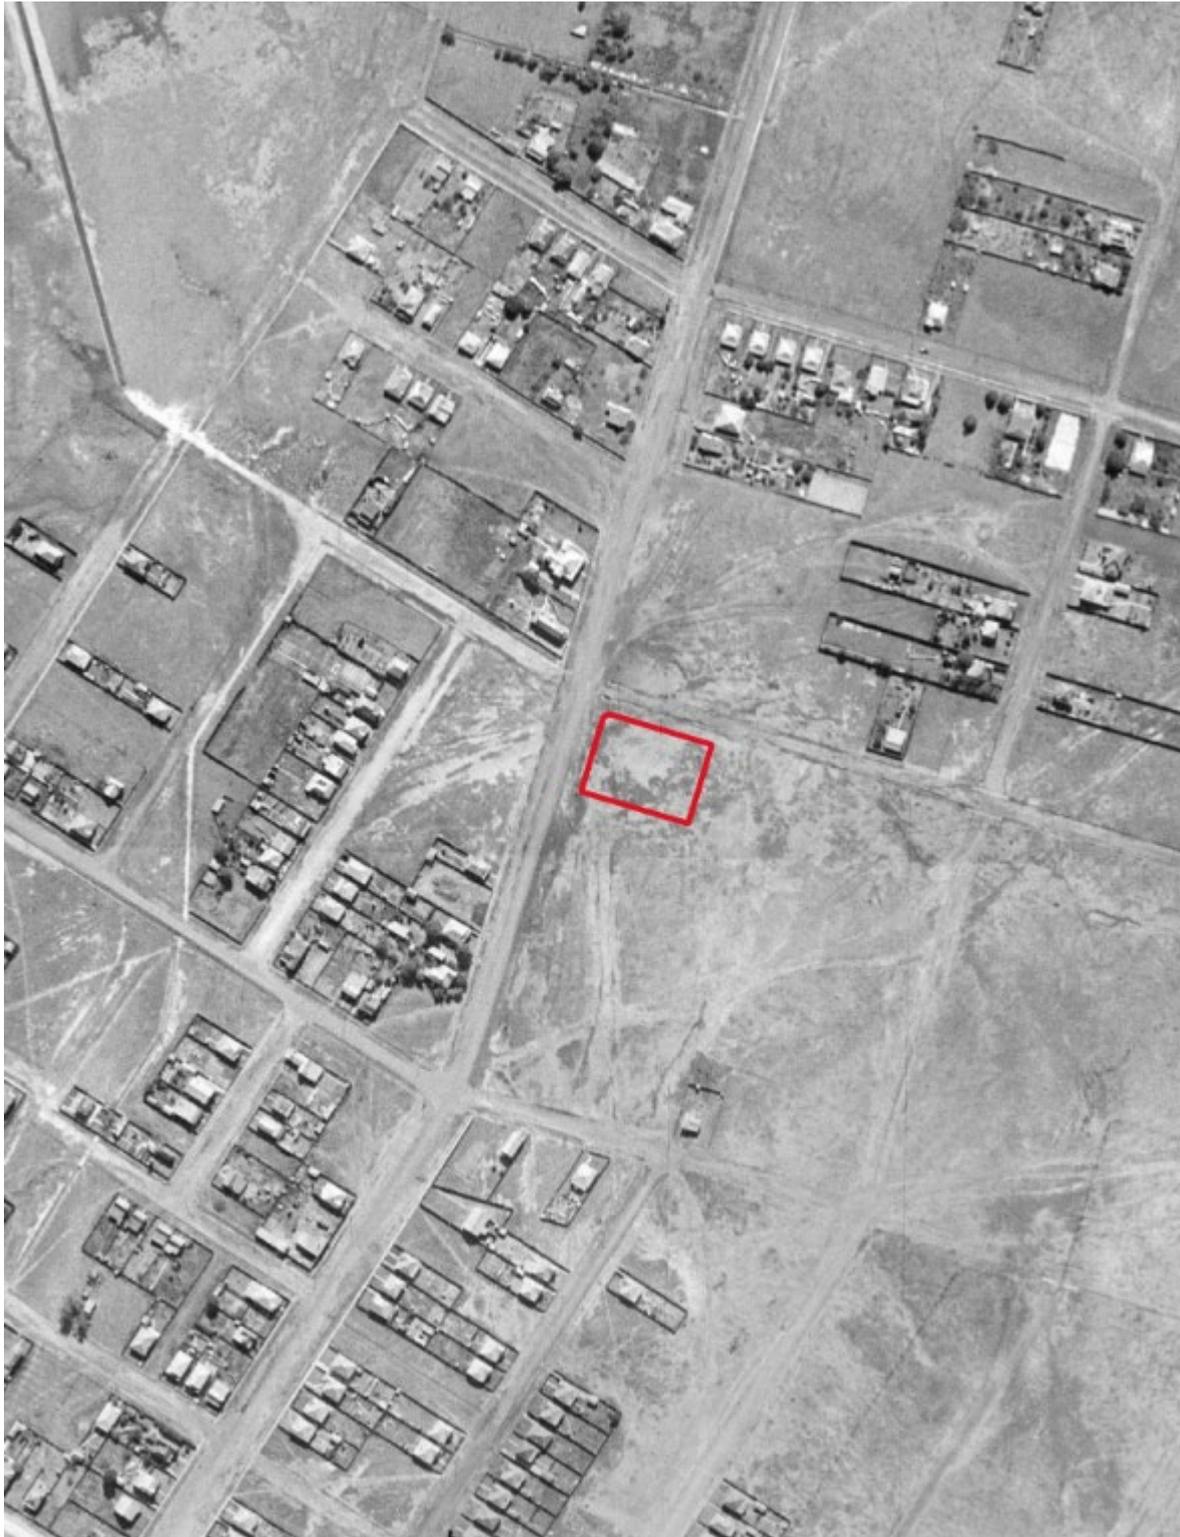
**Figure 49: 1943 aerial imagery showing the Derby Street and Sutherland Street (Silverwater Road). The study area appears undeveloped (construction site outlined in red)<sup>57</sup>**

1943 aerial imagery of the area shows that the site had not been developed by c1940, despite the previous subdivision (Figure 48). Derby Street and Sutherland Street (Silverwater Road) are visible. There is limited written history and imagery of the area from the mid-late twentieth century. Google Earth aerial imagery from 2003-2007 indicates that there was an approximate 35 x 40 metre structure within the study area, however, Google Earth aerial imagery from 2009 indicates that this structure had been demolished by this point. This imagery also reveals that the eastern most, 10 x 40 metre portion of the study area has had no previous developments.

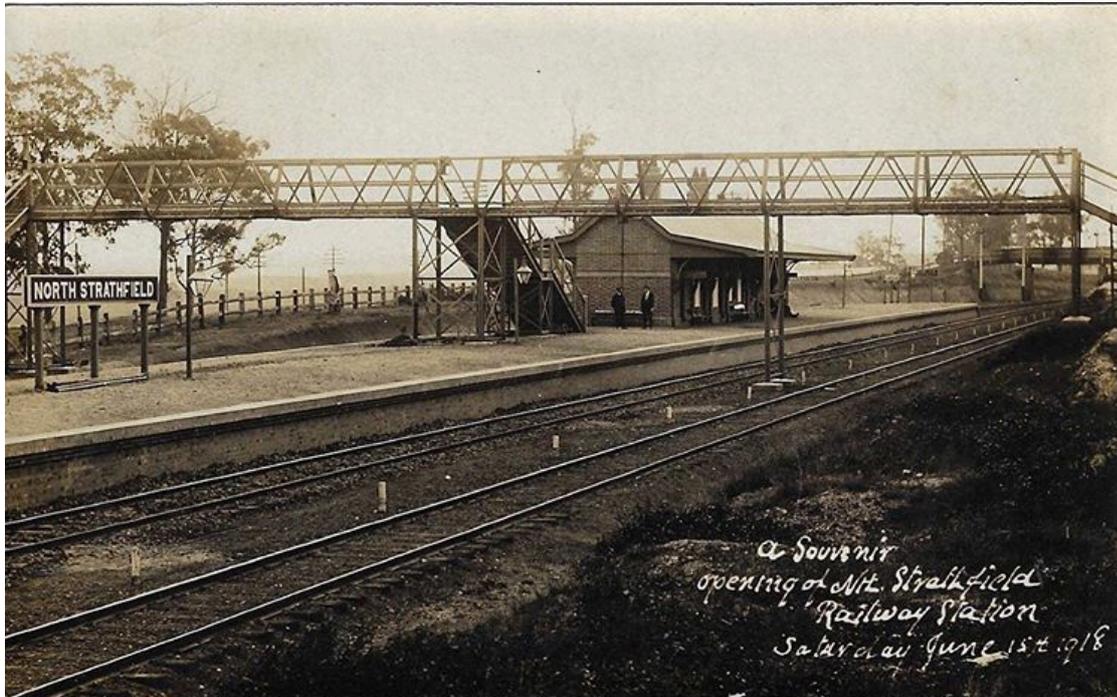
**Figure 64: North Strathfield Station taken 1 June 1918 at opening of station platform. (Source: City of Canada Bay Library)**

North Strathfield Station initially consisted of an island platform with brick station building and connecting steel trellis footbridge. The original footbridge included three stairways with entryways available from Queen Street and Hamilton Street East. The road overbridge at Pomeroy Street had also been constructed at this point. By 1928 a third platform was constructed at the station during the electrification of the rail line.

Several modifications to North Strathfield Station have been undertaken. In 1994 the pedestrian overbridge was replaced with the current concrete bridge, and an existing entrance pathway from Hamilton Street East was removed with the current configuration of the entrance way developed. In 2012, a third entrance was added to the station with a ramp from Pomeroy Street constructed, and the North Strathfield Rail Underpass Project was approved. In March 2019, works on the North Strathfield Station Transport Access Program upgrade commenced, involving accessibility upgrades at the eastern entry of the station off Queen Street. These works include addition of lifts and modifications to the existing overbridge.

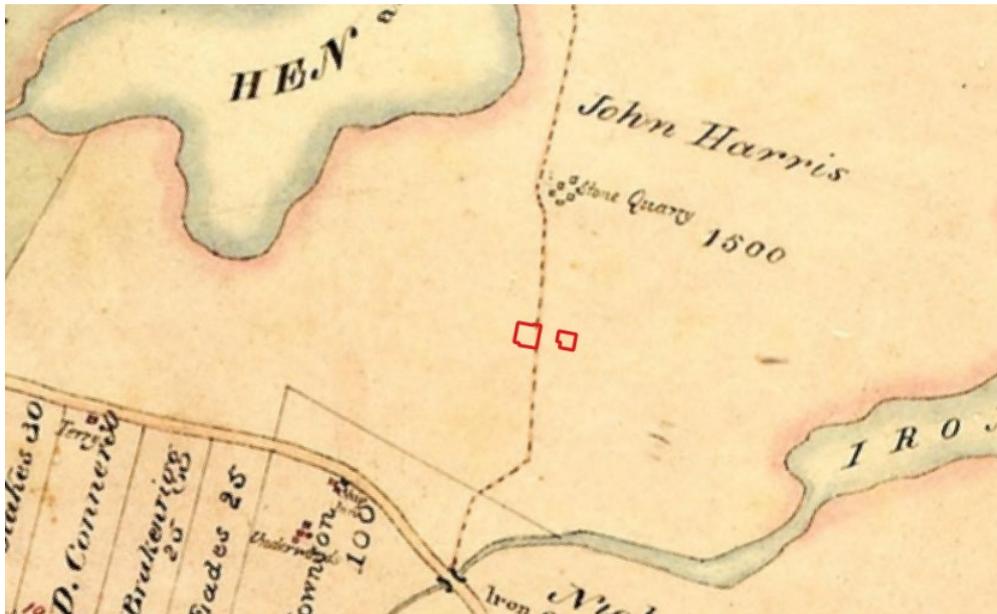
**Figure 73: Detail of Concord Parish map, undated, showing John Harris' grant and the Great North Road alignment (construction site outlined in red)**<sup>102</sup>

In 1788, Captain John Hunter of the *H.M.S Sirius* surveyed the foreshores of the Drummoyne Municipality. This included Iron Cove, Drummoyne, Five Dock Bay and Hen and Chicken Bay. The area became known as the 'Eastern section of the District of Concord' by c1790 and a portion was subdivided by Major Francis Grose, granting farms to members of the NSW Crops in 1794. A number of these grants were reverted to crown land, however in January 1806, Governor King granted the present Five Dock, Russell Lea, Abbotsford and Drummoyne area to Surgeon John Harris (Figure 73). This 1,500 acre area became known as Five Dock Farm.<sup>98</sup>

In 1828, Surveyor-General Sir Thomas Mitchell marked out a new road, passing through Five Dock Farm which would later become known as the Great North Road (Figure 73). The road was formed using convict gangs who cleared the land of trees and bush. The road eventually ran from the junction at Parramatta Road north towards Abbotsford Point, where a punt was installed.<sup>99</sup> Harris sold his holdings at Five Dock to ex-convict Samuel Lyons on 17 September 1836. Lyons subdivided the land with sales occurring from 24 January 1837. 133 lots were auctioned, which varied in size from 2 – 69 acres 'to suit the means of all classes of buyers'.<sup>100</sup>

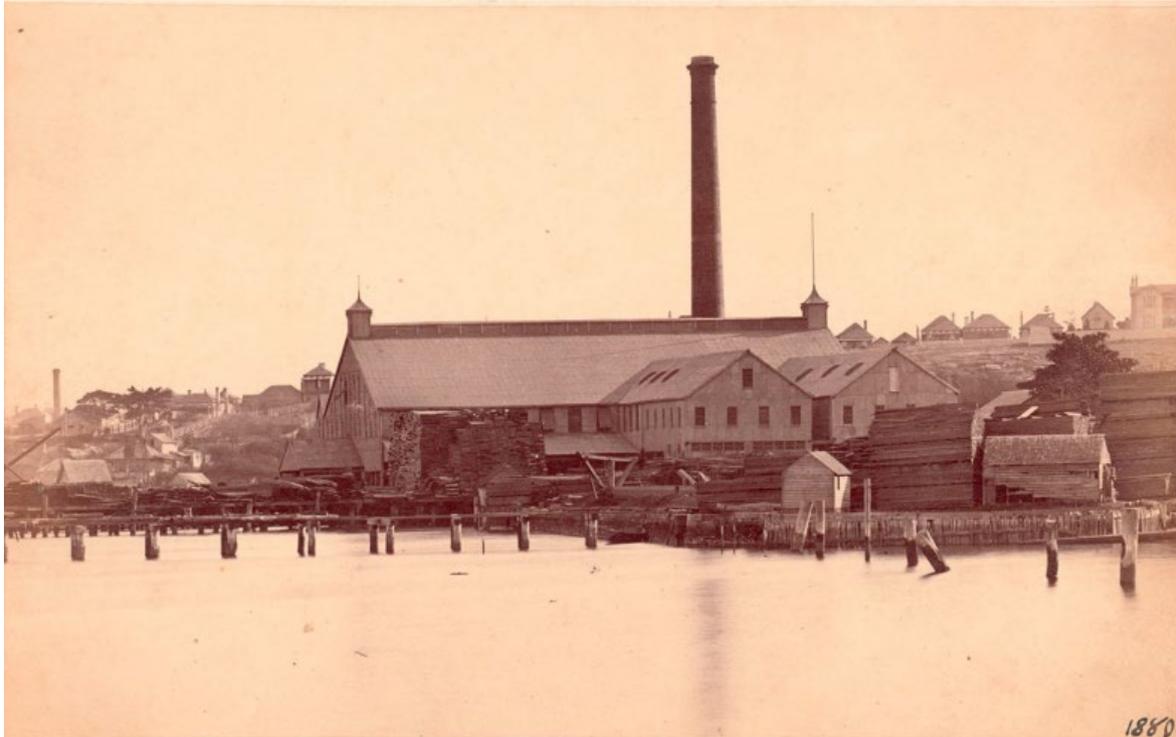
**Figure 85: John Booth and Co., Steam Saw Mills and Joinery Works, Balmain, 1880<sup>120</sup>**

From 1854, White Bay was dominated by John Booth's Steam Saw Mills, the first substantial timber and joinery works within Sydney (Figure 85). Booth, a shipbuilder, had begun the operation in order to take advantage of the need for timber, supplying the emerging boat and ship building industries within Balmain.<sup>116</sup> He was a prominent citizen within Balmain, becoming the suburb's Mayor in 1867. Booth's mills stretched along the Balmain shoreline from Booth Street to Stephen Street. The mills were destroyed in 1874 during a fire but were rebuilt, producing up to 200,000 feet of timber per week at the height of production.<sup>117</sup> The mills sourced timber from their sawmills along the Manning River and northern Queensland and even built their own ships up until the c1880s, at which point, the mills had become the second largest industrial enterprise within Balmain, after Morts Dock.<sup>118</sup>

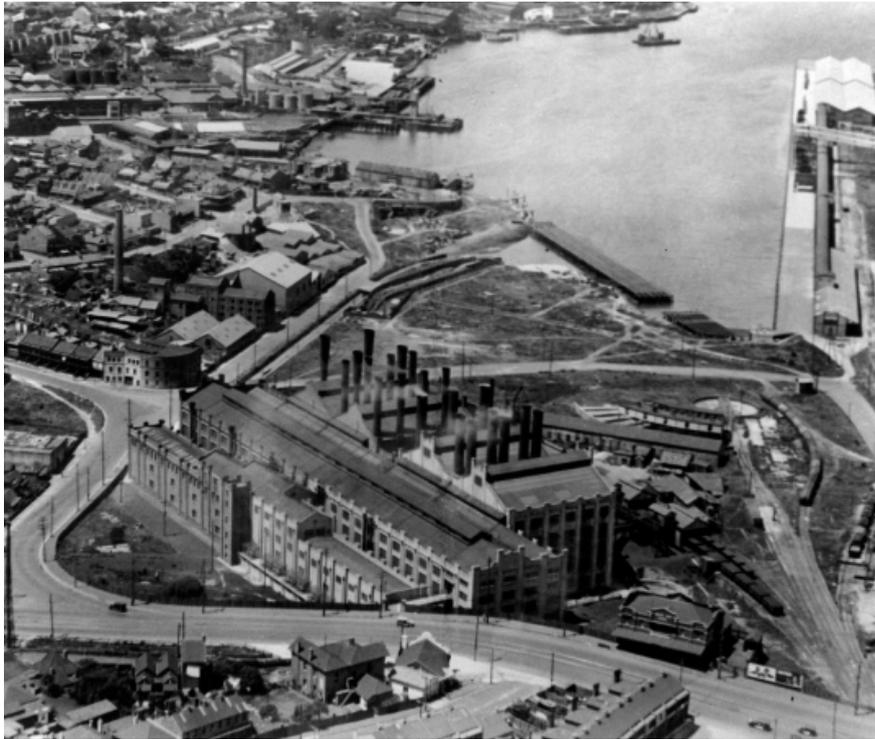
**Figure 90: White Bay Power Station and the White Bay Hotel, c1930 (City of Sydney Archives SRC352)**

The White Bay Power Station was constructed by the NSW Railway Commissioners in order to support the ever-expanding tramway network; to facilitate the anticipated electrification of the railway system and the proposed underground railway system within the CBD (Figure 90).<sup>132</sup> In addition, the tramway network within Sydney was much more extensive than in Melbourne at this time, and was challenged by much steeper topography. As such, a newer, larger and more flexible power station was required to fulfil Sydney's needs.<sup>133</sup>

Construction of the facility began from 1912-1917 during which time, the turbine hall, switch house and one boiler house were built. At this stage, the buildings had been completed but most of the plant had yet to be installed, as such, the power station commenced operation with one 7500kw, 6600-volt, 25 cycle turbo alternator and associated boiler equipment on temporary foundations. From 1916-1919, two new Turbo-Alternators and the No. 9 Alternator were installed at White Bay.<sup>134</sup> From 1923-1928 White Bay was extended utilising steel framing and reinforced concrete, rather than brickwork.<sup>135</sup> In addition, three 22,000kW, 11,000-volt, 50 cycle Turbo Alternators and two 18,750kw 6600 volt, 25 cycle Turbo Alternators were installed.

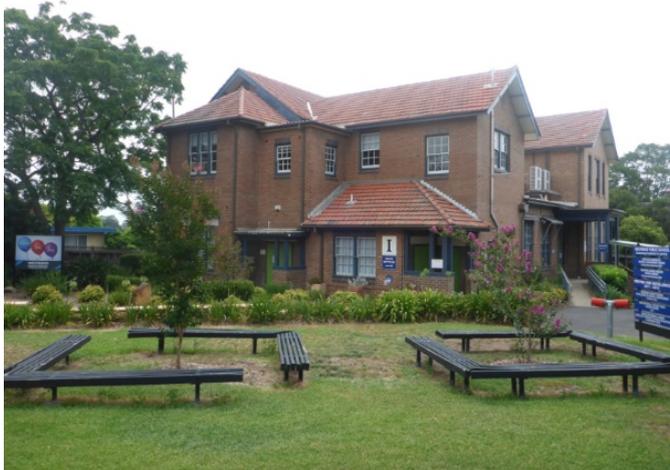
**Figure 108: Westmead Public School from Hawkesbury Road. Artefact Heritage 2019.**

Significance	Local
Description	Brick classroom blocks typical of government designed schools constructed during the early twentieth century. Building features include hipped and gabled roofs which continue over timber framed verandahs giving access to individual classrooms. In addition, windows generally timber framed.
Statement of significance	<i>Westmead Public School has local historic and social significance from its role as the local public school for the area since 1917. The building group also provides evidence of the growth of community facilities which accompanied the increase in population throughout Holroyd in the Interwar years. Aesthetically the site has local significance being enhanced by the degree to which its buildings have retained early fabric and detailing. Mature tree planting also enhance the aesthetic significance of the site as an attractive and notable local landmark.</i>

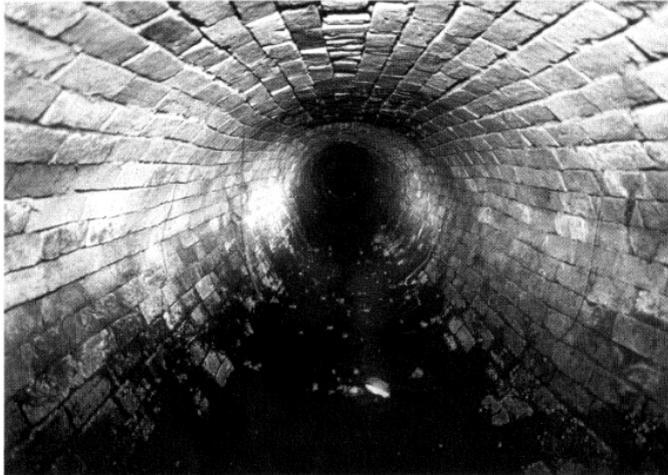
**Figure 122: A section of the Convict Drain. Edward Higginbotham 1983**

Description This convict drain was created to disperse stormwater, and runs on an alignment from the Church and Darcey Street junction, discharging into the Parramatta River. The 1 metre diameter circular brick barrel drain consists of two courses of sandstock bricks loosely cemented with mud mortar and packed with sand and clay.

Heritage impact assessment The Parramatta metro station construction site marginally encroaches on a portion of the curtilage of the convict drain heritage item, located beneath Macquarie Lane. The exact location and fabric condition of the portion of the drain in the location within the construction site is unknown. Previous archaeological studies have identified the drain at a variable depth in different locations in Parramatta, and as such the precise depth of the drain that is within the construction site is also unknown. Construction activities for Stage 1 could potentially result in direct physical impact on the convict drain. Stage 1 would result in demolition of all modern buildings and structures within the construction site. Demolition of modern buildings on the site would not result in any substantial adverse heritage impact, and would not result in the item's heritage listing eligibility being reduced. It is possible that minor impact to the heritage item could occur due to vibration or accidental damage during construction, which could potentially result in localised physical impact although this would be minor in nature. The archaeological assessment and impacts are covered separately in Section 7.3.

A portion of the curtilage of the heritage item is located within the construction site. The heritage item is predicted to experience vibration levels above the cosmetic damage screening criteria, however, the exact location, fabric condition and depth of the convict drain heritage item are unknown. Further assessment (including structural assessment) and vibration monitoring (if required) would be completed in accordance with Technical Paper 2. This would be based on the confirmed location of the item relative to construction activities.

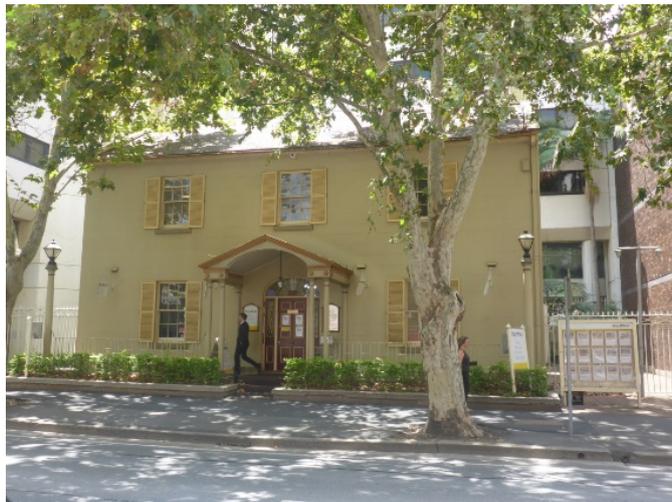
**Figure 126: Kia Ora from Macquarie Street. Artefact Heritage 2019**

Description Kia Ora was developed from 1841 and is a two-storey townhouse on sandstone foundations constructed using rendered brick with a gabled slate roof. The structure is symmetrically designed and features small paned windows with shutters, sandstone sills and brick flat arches, and a six panelled timber simple mould door with elliptical fanlight and sidelights with glazed upper panels and timber below the lock rails. Additional elements include a sandstone verandah and fence foundations.
