# **Westmead to The Bays and Sydney CBD**

**Technical Paper 3  
Non-Aboriginal heritage**

# Sydney Metro West

Non-Aboriginal Heritage

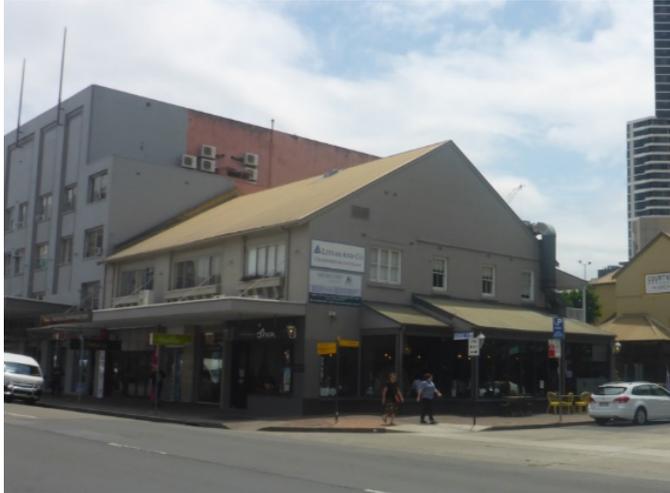
**Figure 127: Dr Pringle's Cottage from George Street. Artefact Heritage 2019**

Significance	Local
Description	Dr Pringle's Cottage is a two storey building including three shops facing George Street. It includes features such as a gabled corrugated steel roof; upper floor enclosed verandahs, with corbels supporting brick balustrade coping; and solid brick eastern and northern walls with string course at original eaves line.
Statement of significance	<i>Dr Pringle's Cottage is of significance for Parramatta for historical, scientific and reasons of rarity. This two-storey Colonial Georgian house, built in c1832 with incorporated c1911 shops, demonstrates changes in use and fabric since early settlement and has the potential to provide further information on the local history.</i>
Impact type	No impact
Heritage impact assessment	<p>This heritage item is not located within the construction site, therefore there would be no direct impact. <b>Direct impact: Neutral</b></p> <p>The heritage item is not located immediately adjacent to the construction site and vibration is predicted to be below the cosmetic damage screening criteria. Potential direct impacts associated with vibration are not anticipated. <b>Potential direct: Neutral</b></p> <p>Stage 1 would result in demolition of development and construction activities on the southern side of George Street, directly opposite Dr Pringle's. This would change the wider context of the historic building. This context has been previously altered by modern development within and surrounding the construction site, and the adjacent buildings are not considered to represent a significant visual element in the surrounding setting of Dr Pringle's Cottage. <b>Indirect impact: Negligible</b></p>

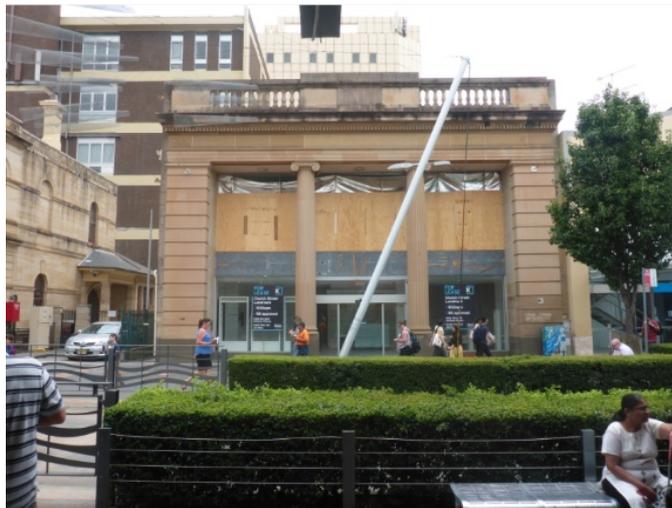
**Figure 132: HMV from Church Street. Artefact Heritage 2019**

The two-storey HMV building was developed from 1927 onwards. The structure was constructed on grey granite foundations, clad in sandstone and includes a balustrade sandstone parapet with frieze set on two wide-banded piers. In addition, two Ionic fluted columns, set on grey granite pedestals, flank the main entrance. The rear of the building is roofed using a terracotta hipped roof; whereas the front of the structure is roofed using a corrugated iron skillion roof from the parapet. Additional features include a mirrored glass window wall which was installed in c1965.

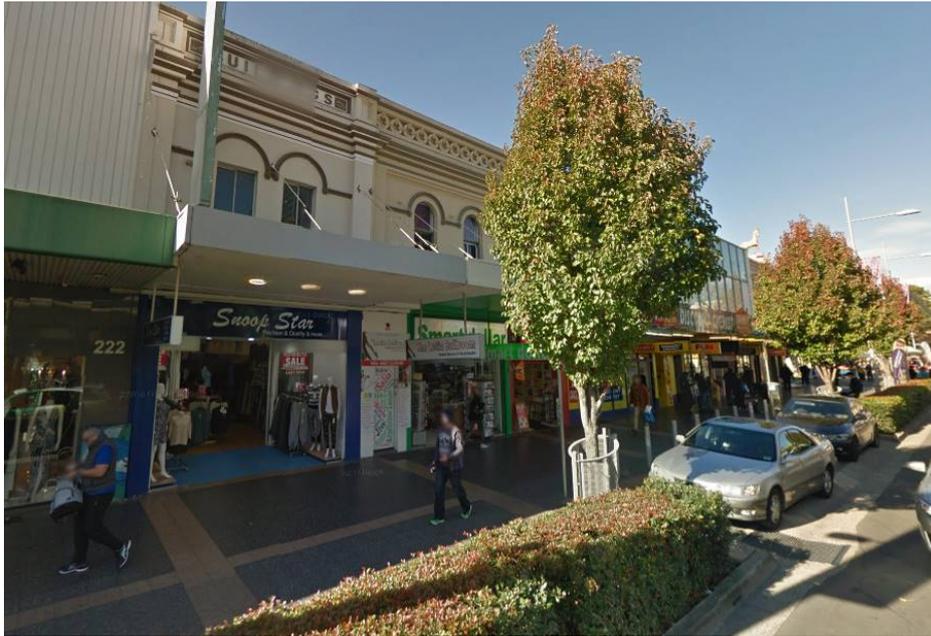
The building located at 220 Church Street within the Parramatta metro station construction site is a late 19<sup>th</sup> century commercial building, constructed circa 1880s. The two-storey building is designed in the Victorian Italianate style of rendered brick construction with rendered mouldings and decorative features, and is associated with the adjoining heritage listed commercial building 'Horse Parapet Façade and Potential Archaeological Site'. The current use of the building is commercial.

Figure 138: View of building at 220 Church Street<sup>165</sup>

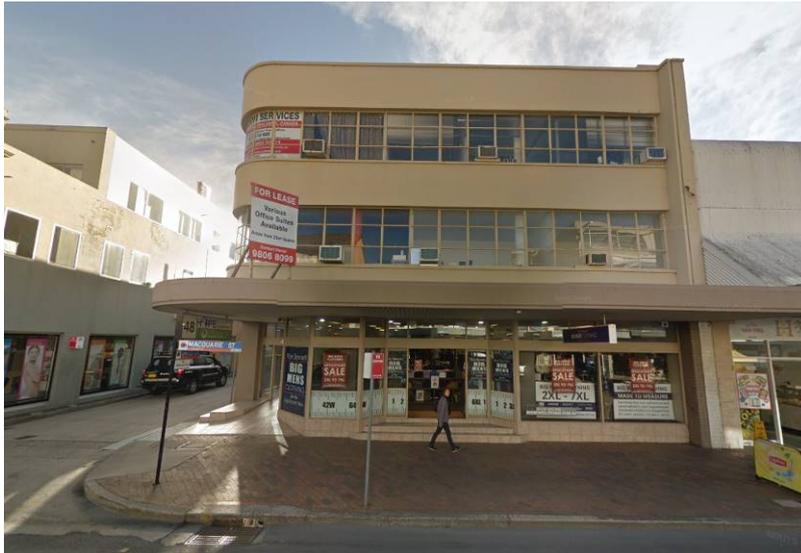
The building at 48 Macquarie Street is within the Parramatta metro station construction site. The building is a mid 20<sup>th</sup> century Inter-War Moderne style commercial building. The three-storey building is situated on a corner block bound by Macquarie Street and United Lane, and is of painted brick construction with a curved façade. The current use of the building is commercial.

Figure 141: View to building at 48 Macquarie Street, Parramatta<sup>168</sup>

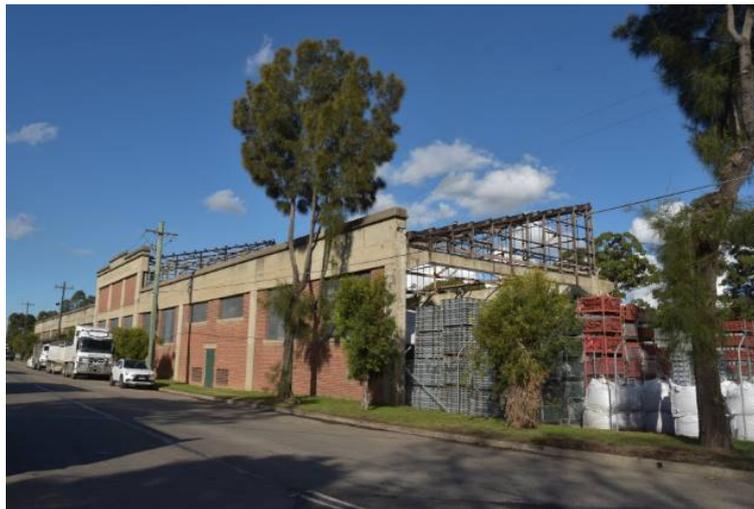
**Figure 153: RTA Depot from Unwin Street. Artefact Heritage 2019**

The heritage item is located within the construction site. The heritage item is predicted to experience vibration levels above the cosmetic damage screening criteria. Further assessment (including a structural assessment) and vibration monitoring (if required) would be completed in accordance with mitigation and management measures detailed in Technical Paper 2.

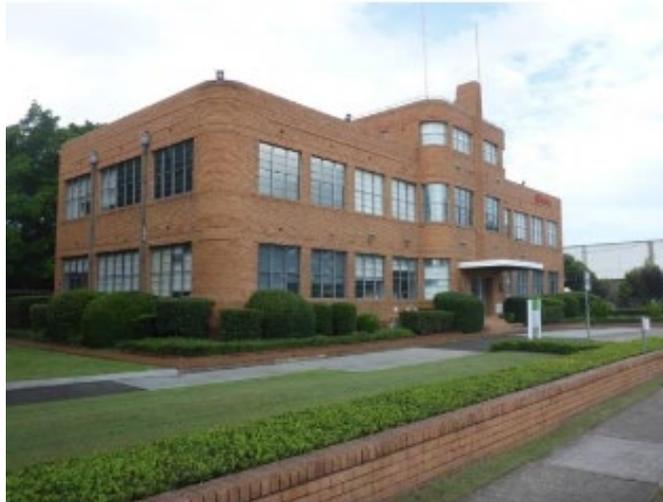
**Figure 154: Capral Aluminium from Unwin Street. Artefact Heritage 2019**

The Capral Aluminium complex is located immediately adjacent to the Clyde stabling and maintenance facility construction site, and would have direct views between the historic office building and the construction site. The introduction of structures over Duck Creek and A'Becketts Creek is not expected to cause indirect (visual) impact above minor to the heritage item due to the extensive vegetation screening along the alignment of the creeks. The heritage curtilage for the item covers the entire lot boundary, and significant extant fabric is mainly limited to the multi-storey office

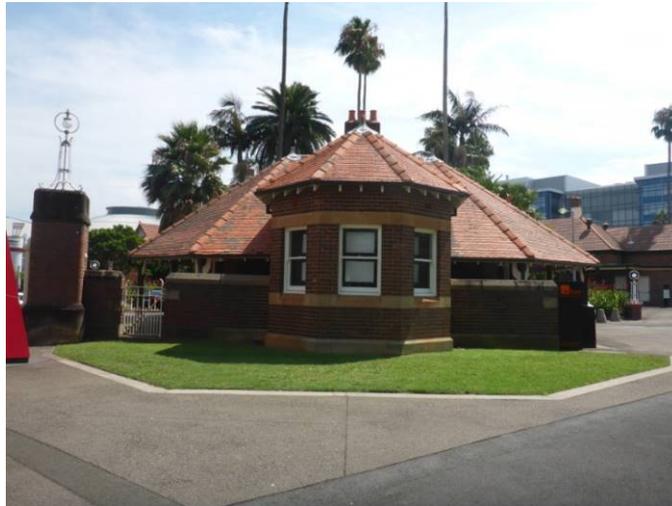
**Figure 171: State Abattoirs. Artefact 2019**

A distinctive component within the existing modern environment of Sydney Olympic Park is the remnant built and landscape elements associated with the heritage listed State Abattoirs. This includes an assortment of attractive Federation era brick buildings with terracotta tiled roofs and plastered walls, a carriage loop, palm grove, garden beds, interpretive elements, and other landscaping. Of particular interest, a small single-storey face brick building, the former Gatehouse, is located on the corner of Showground Road and Herb Elliot Avenue.

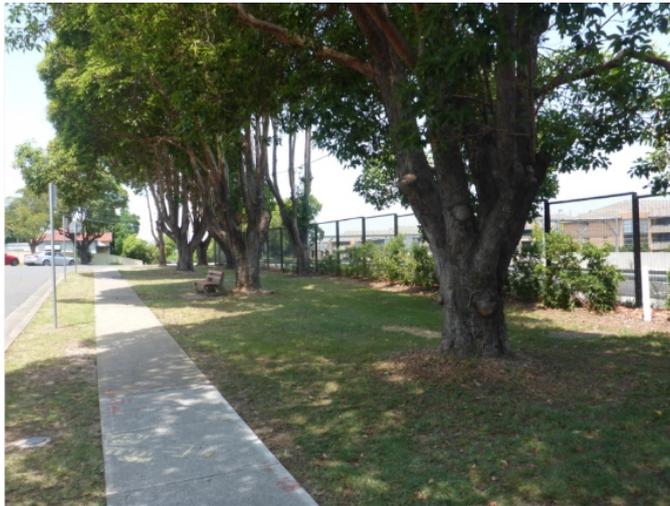
**Figure 182: Street Trees from Queen Street. Artefact 2019**

Significance	Local
Description	The Street Trees heritage item comprises a row of mature Brush Box trees that are located along the western side of Queen Street, fronting North Strathfield Station. The Brush Box trees were planted around the 1940s.
Statement of significance	<i>The Street Trees are characteristic street planting of a row of Brush Box from c1940s forming a significant element within the streetscape.</i>
Impact type	No impact
Heritage impact assessment	<p>This heritage item is not located within the construction site, therefore there would be no direct impact. As site clearing works are not required at the southern construction site, impact by way of disturbance to the root systems is not anticipated.</p> <p><b>Direct impact: Neutral</b></p> <p>Construction works for Stage 1 would occur within and adjacent to the Street Trees heritage item. The southern construction site for the North Strathfield metro station would be near the Street Trees heritage item and would involve utilisation of an existing hardstand carpark for construction site activities. The use of this site for construction, including site parking, site office and amenities, would not substantially alter the existing visual amenity of the locality and as such any associated visual impact on the setting and context of the nearby Street Trees heritage item would be negligible in nature.</p> <p><b>Indirect impact: Negligible</b></p>

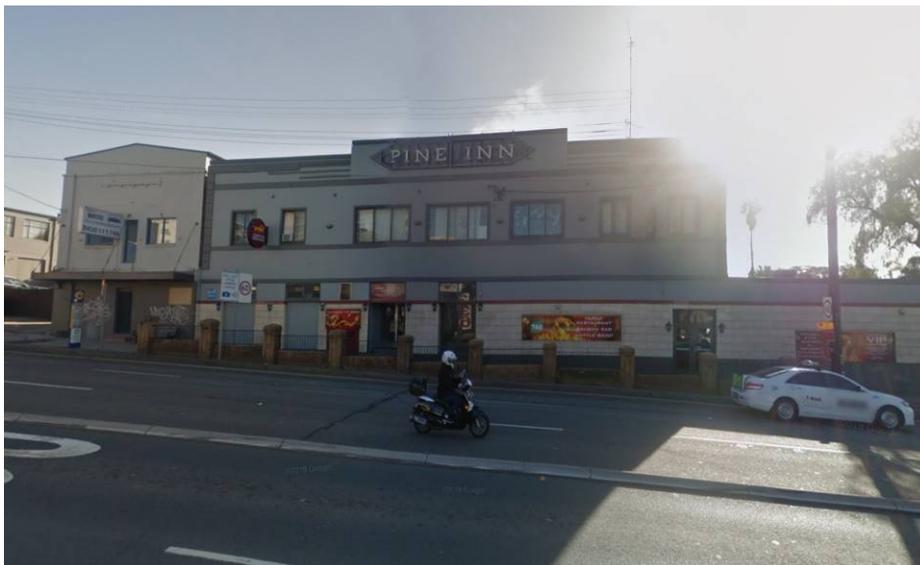
Figure 199: View across Parramatta Road to Pine Inn<sup>182</sup>

The Pine Inn, located at 19 Parramatta Road is within the Burwood North Station northern construction site. The building is a mid 20<sup>th</sup> century Inter-War Art Deco style hotel building, constructed on the site of the former Oriental Hotel. The hotel is a two-storey building of painted brick construction with decorative mouldings and linear features. The building's current use is as a commercial pub.

<p><b>C – Aesthetic or Technical Significance</b></p>	<p>The Pine Inn is an Inter-War Art Deco style building, and exhibits several features that are typical of its type. The building retains its bold rendered brick façade with restrained decorative mouldings and linear features, which reinforce the horizontality of the building. The building has been relatively altered, with modifications to the ground floor openings, replacement of original windows and removal of the original awning. The interior of the building was not accessed. These modifications have diminished the contribution of the hotel to its surrounding streetscape setting.</p> <p>The item does not meet the local significance threshold under this criterion.</p>
<p><b>D – Social Significance</b></p>	<p>Whilst the Pine Inn building at 19 Parramatta Road has some associations with the commercial development along Parramatta Road during the 20<sup>th</sup> century, and likely has some associations with members of the local community and staff, it does not appear to retain any substantial social significance from a heritage standpoint.</p> <p>The item does not meet the local significance threshold under this criterion.</p>

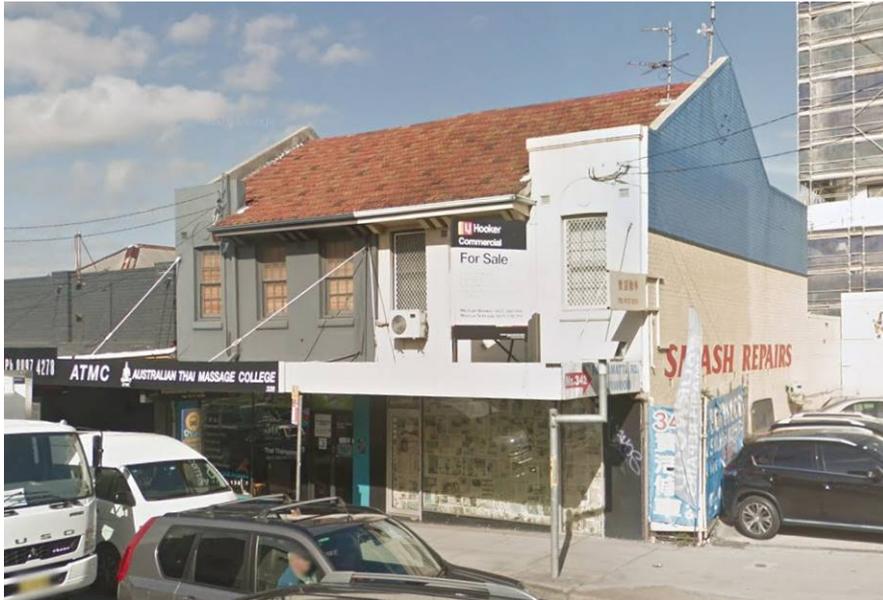
**Figure 202: View to building at 338-340 Parramatta Road, Burwood<sup>185</sup>**

The building at 338-340 Parramatta Road is within the Burwood North Station southern construction site. The two-storey building is a late 19<sup>th</sup> century Victorian era building of painted brick construction with projecting parapet, tiled gabled roof and original windows with moulded sills. The current use of the building is commercial.

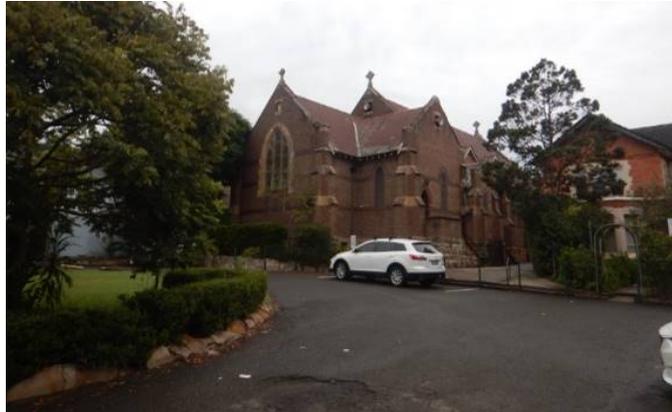
**Figure 215: St Alban's Anglican Church from within Church yard. Artefact 2019**

Description St Alban's Anglican Church was constructed in 1923 in the ecclesiastical Gothic style. The church is set back from the Great North Road to incorporate an attractive lawn and rose garden, which considerably enhance the setting of the church precinct. The church was built using brick in a cruciform plan, with a complex slate roof including parapet gables. Additional features include stone and dark brick bands used for decoration, and stained-glass windows throughout.

The heritage item is located adjacent to the construction site and is predicted to experience vibration levels above the cosmetic damage screening criteria. Further assessment (including a structural assessment) and vibration monitoring (if required) would be completed in accordance with mitigation and management measures detailed in Technical Paper 2.

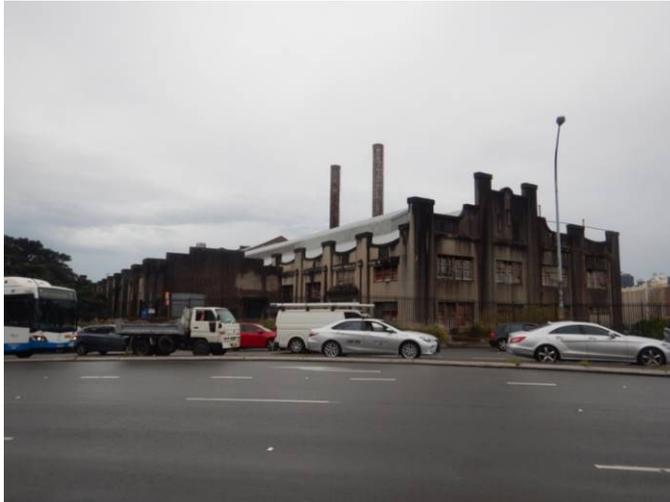
**Figure 227: White Bay Power Station from Robert Street. Artefact 2019**

The White Bay Power Station site and associated SHR curtilage is located within the construction site. Vibration is predicted to exceed the cosmetic damage criterion at one structure within the heritage curtilage. Further assessment (including a structural assessment) and vibration monitoring (if required) would be completed in accordance with mitigation and management measures detailed in Technical Paper 2.

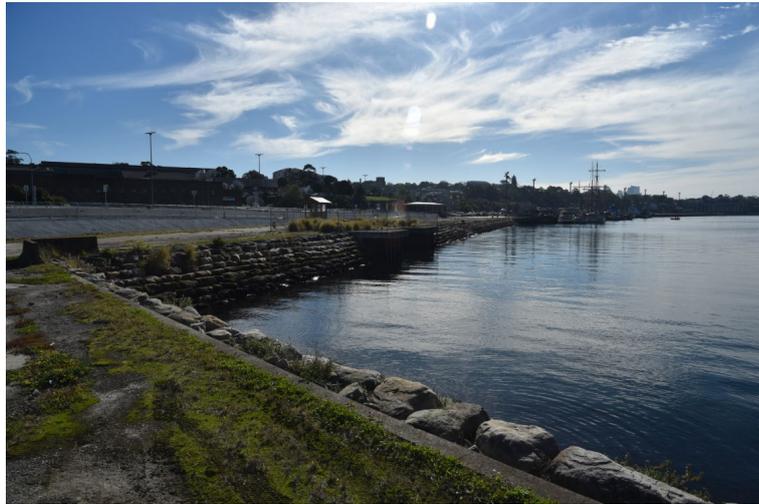
**Figure 229: White Bay Power Station (Inlet) Canal – White Bay. Artefact Heritage 2019.**

The White Bay Power Station (Inlet) Canal is partially located within the construction site. Vibration is predicted to be above the cosmetic damage screening criteria. Further assessment (including a structural assessment) and vibration monitoring (if required) would be completed in accordance with mitigation and management measures detailed in Technical Paper 2.

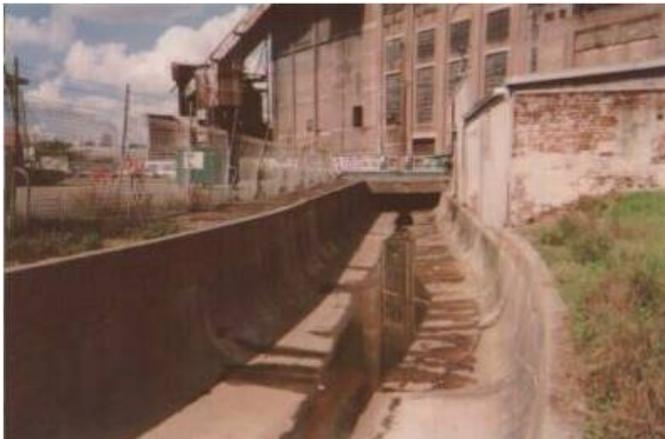
**Figure 231: Beattie Street Stormwater Channel No. 15 with White Bay Power Station in background. OEH n.d.**

Significance	Local
Description	The Beattie Street Stormwater Channel No. 15 spans an approximate area of 72 ha within the municipality of Leichhardt. Its outlet is located at White Bay, extending from this point, west to Roberts Road, crossing Mansfield Road, Goodsir and Reynolds Streets to Beattie Street. Constructed in 1893, the channel ranges in size from 18'2" x 4'6" - 3'3" x 2'4".

*Beattie Street Stormwater Channel No. 15 includes the channel bed, walls and coping. The visual curtilage of the channel would vary along the channel length depending on surrounding land uses. The visual curtilage is limited by the fact that the stormwater channel is located predominantly below ground. A small section of the channel is open between Robert Road and Parson Street. The open section of the channel can only be observed from the roadway and is flanked by industrial properties.*

Vibration is predicted to be below the cosmetic damage screening criteria. Potential direct impacts associated with vibration are not anticipated.  
**Potential direct impact: Neutral**

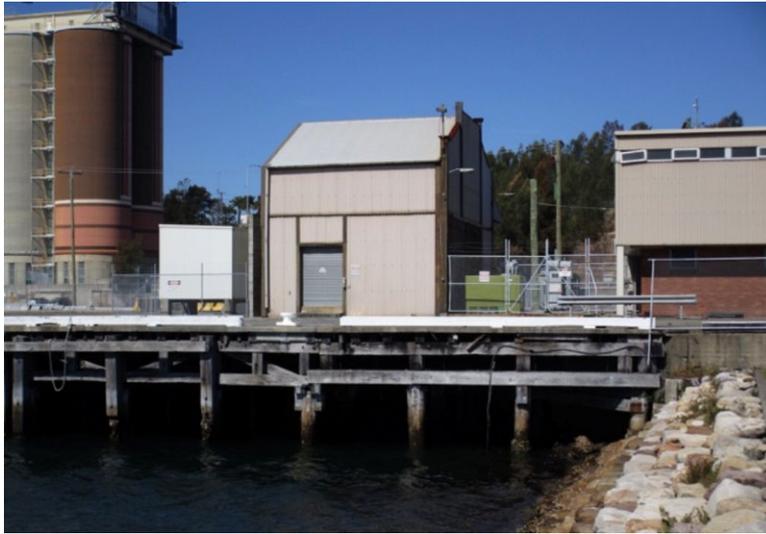
**Figure 233: Former warehouse shed**<sup>197</sup>

*“The building is the southern-most and last remaining portion of a warehouse building that originally extended north-east along the north-western edge of Glebe Island. The building appears to be a combination of timber and steel post and beam construction clad externally with corrugated metal. The south (end) elevation includes a small section of external brick walling. The south-east elevation consists of an overhanging steel framed canopy, likely related to earlier functions of loading and unloading on land-side.”*

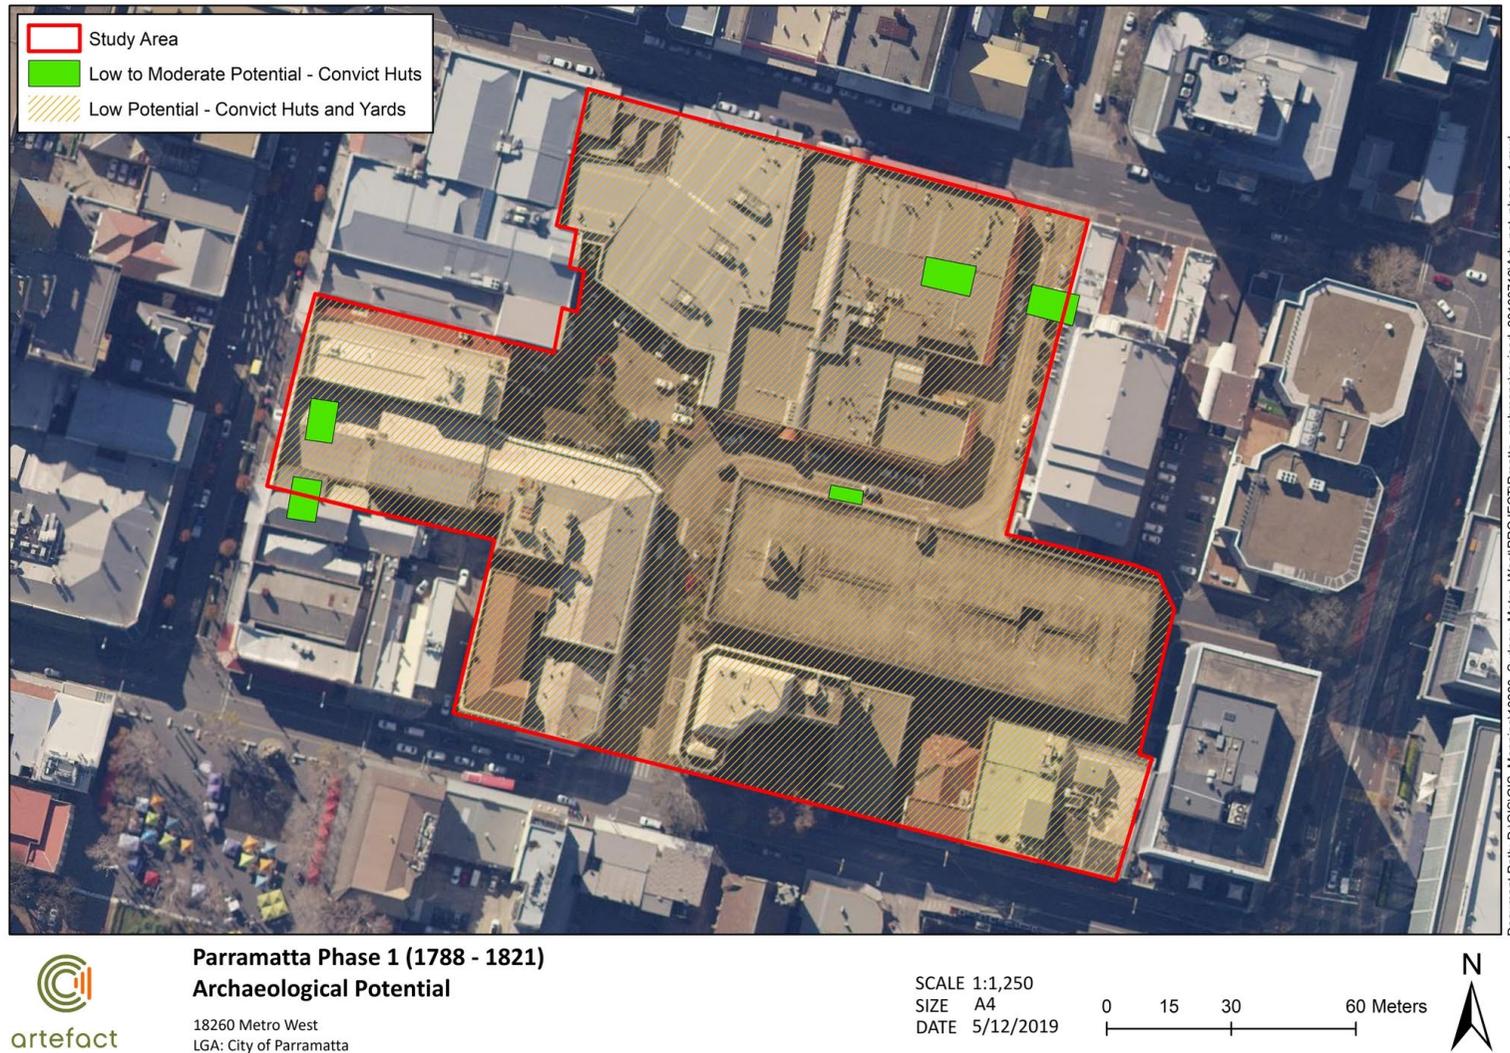
Figure 238: Areas of archaeological potential for Phase 1 (1788 – 1821) at the Parramatta metro station construction site. Convict hut locations determined from Archaeological Zoning Plan figures for 1792
