Chapter 11

Soils and water

11.1 Introduction

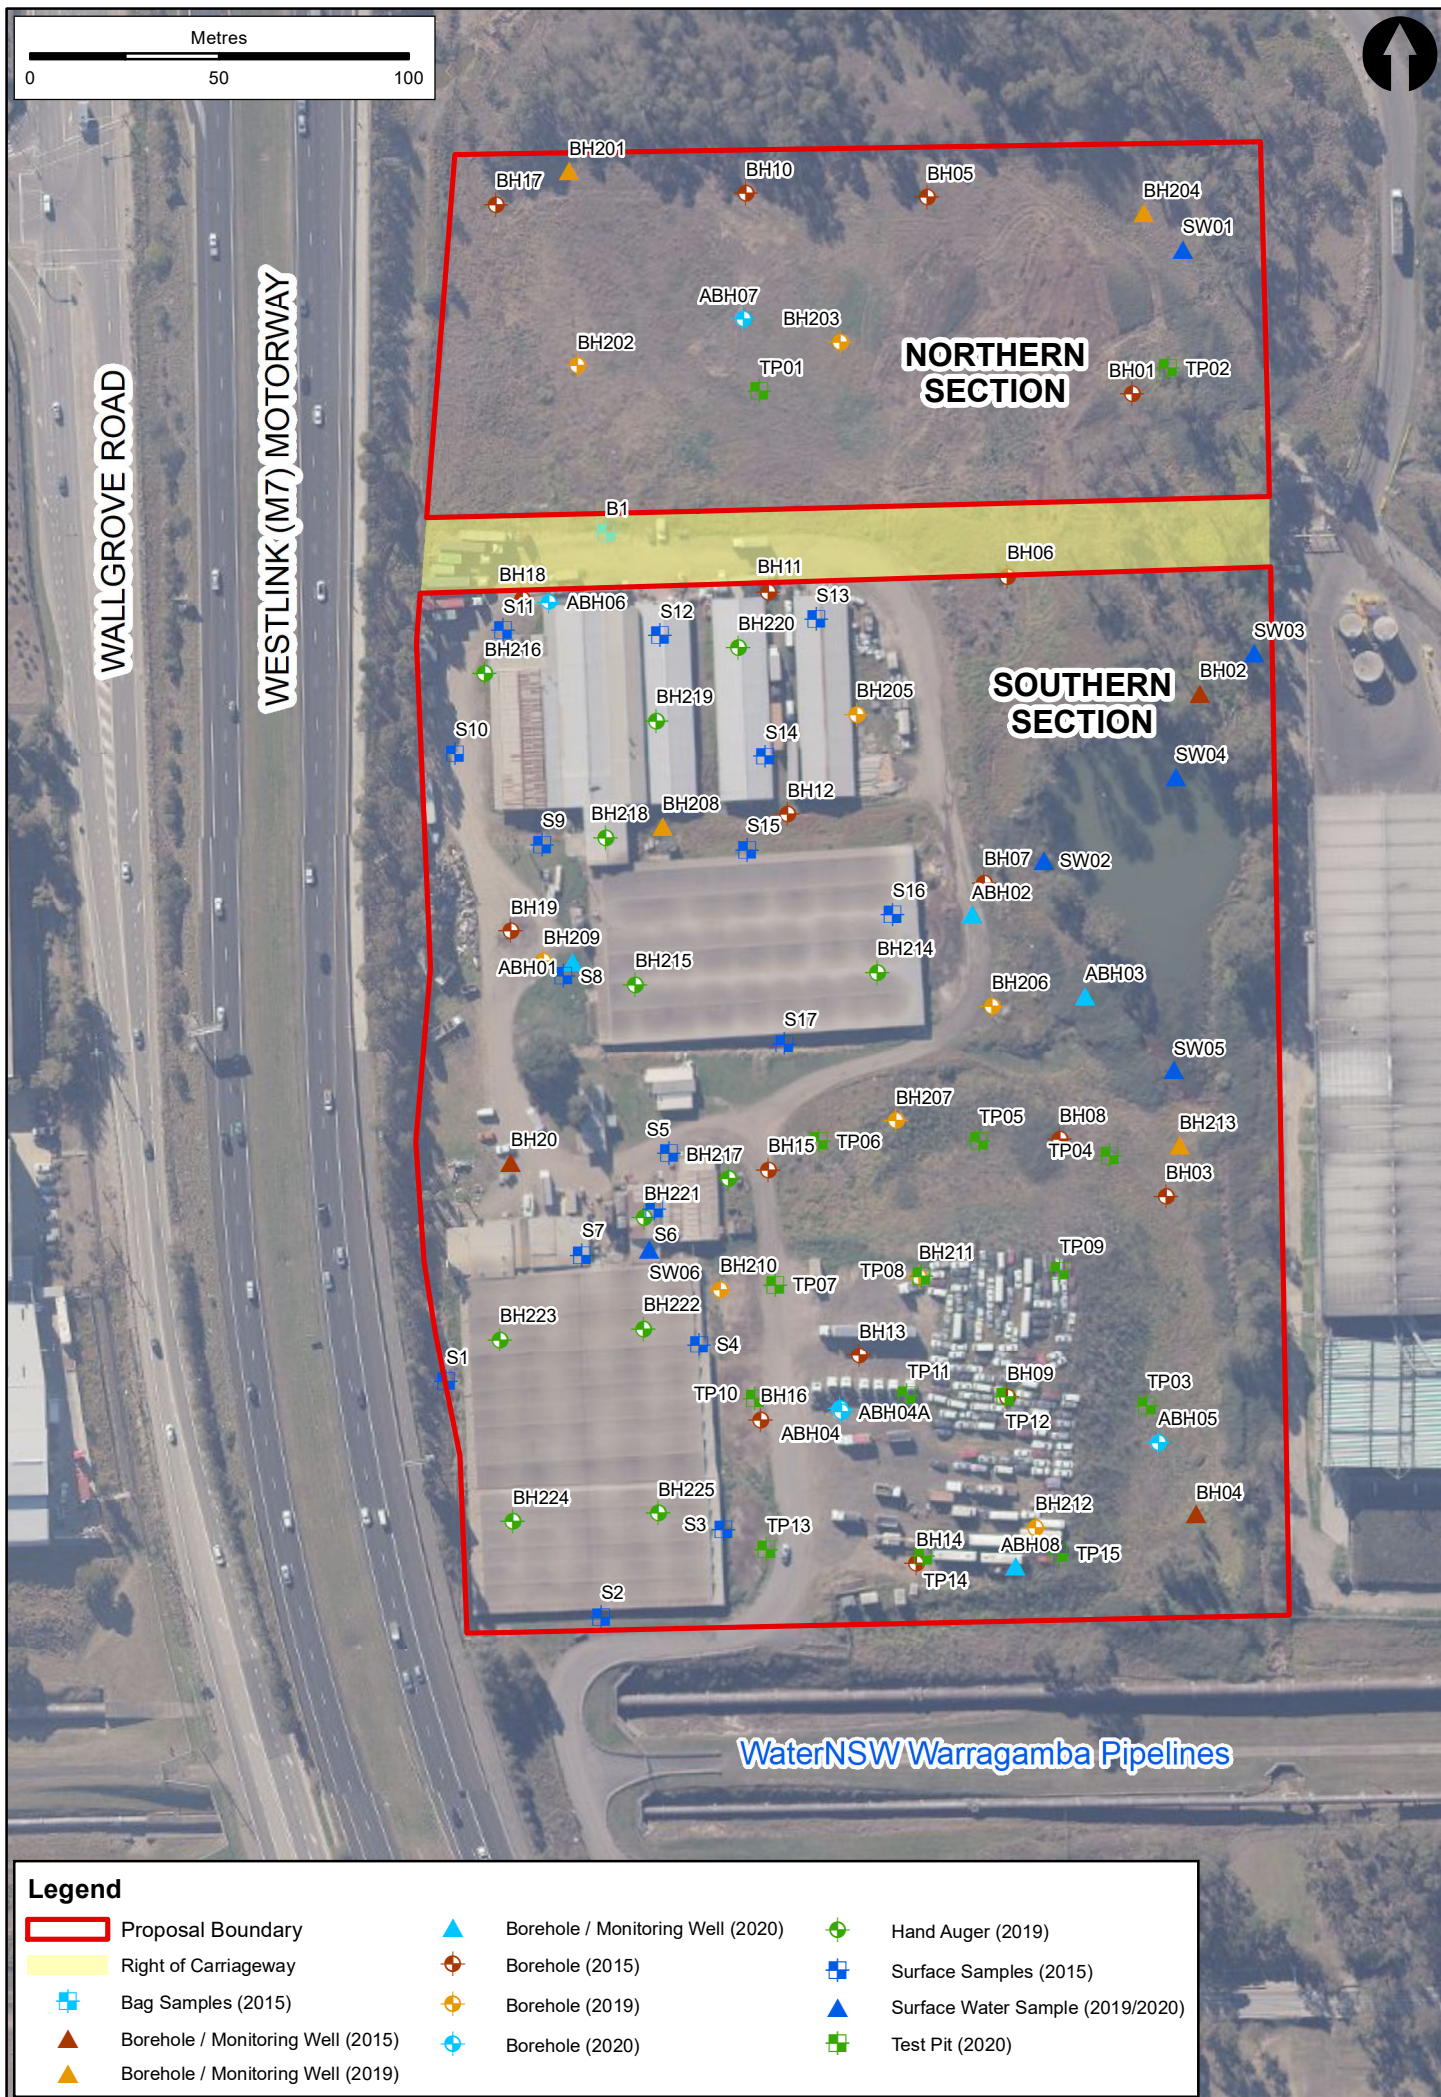
Figure 11.1: Testing locations

Additional testing as a part of the DSI in 2020 comprised the drilling of four additional boreholes, which were converted into groundwater wells and the excavation of 15 test pits.

The testing locations are shown on **Figure 11.1** below.

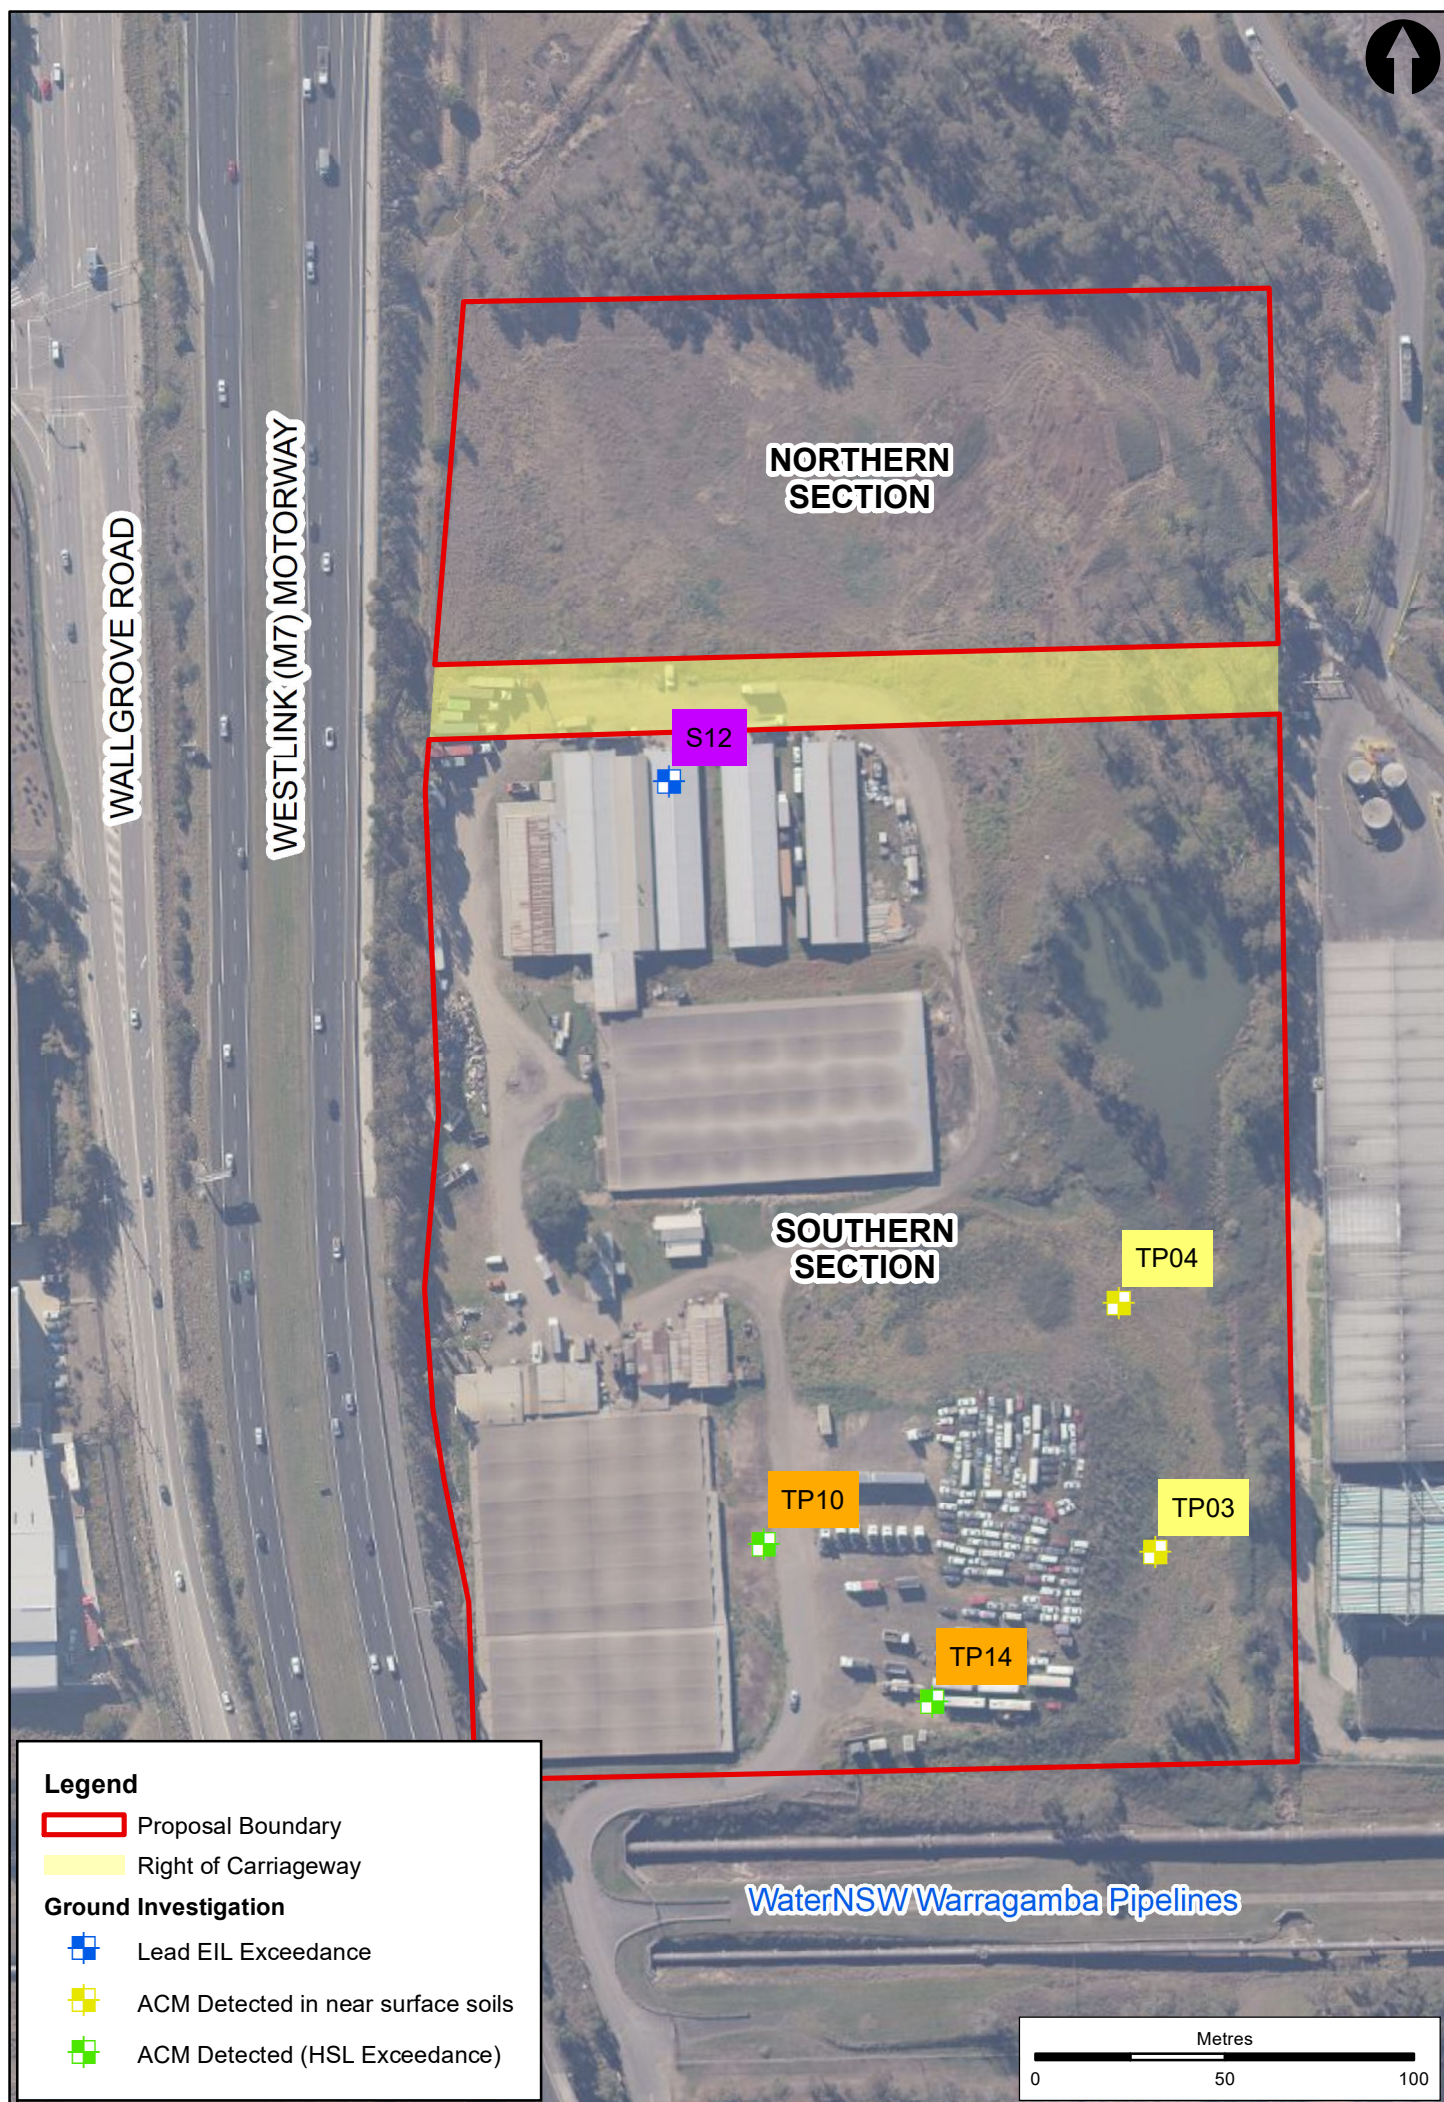
Figure 11.2: Identified contamination at the proposal site

Lead levels of 3,700mg/kg were found in a 2019 sample (S12) (**Figure 11.2**). This represents an exceedance of 2,200mg/kg above the NEPC (2013) standard of 1,500mg/kg. This exceedance was associated with high levels of lead contained in paint samples from the nearby buildings and is not considered to be representative of the soils across the site.

Potential asbestos containing material (ACM) was observed in 11 samples at eight locations, primarily associated with the raised fill platform and surrounding areas in the southern section of the site. **Table 11.1** summaries the asbestos HSL exceedances. The HSL for bonded ACM is 0.05% w/w (weight for weight), and for fibrous asbestos (FA) and asbestos fines (AF) the HSL is 0.001% w/w. The testing locations which had elevated asbestos are shown in **Figure 11.2**

The DSI (**Technical report G**) found existing contaminants onsite as outlined in the existing environment in **Section 11.2**. Construction activities, including the demolition of buildings and the excavation of soil, have the potential to mobilise these contaminants.
